Intersection ID: N/A	Main Street: LANGWELL_LN	Cross Street: INVERNESS_BAY_RD	Location:	SW
ADA ID: 1F3AA762582D	Ramp Type: Perp	Initial Pass/Fail: Fail	Overall Compliance: No	Severity Score: 13.75

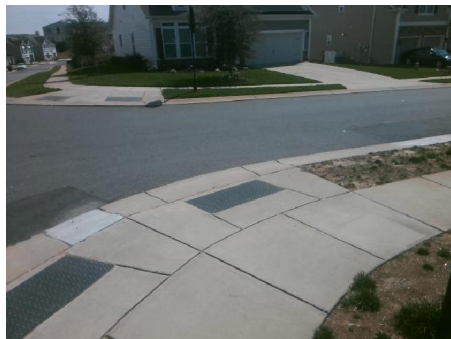
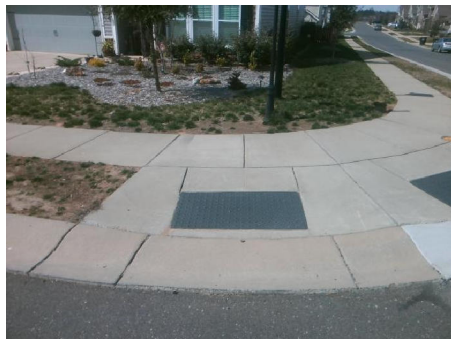
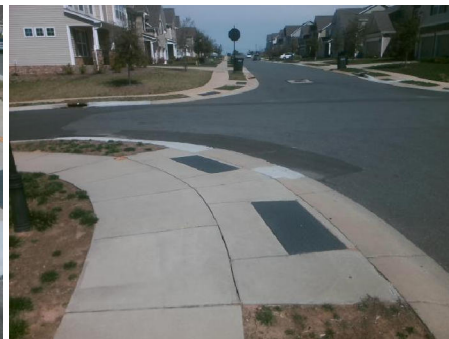
Possible Solutions:			Compliance	Description	Data	Compliance	Description	Data
Remove & Replace Entire Ramp.			N/A	Ramp Length (in)	49.0	No	Ramp Slope (%)	10.9
			Yes	Ramp Width (in)	48.0	No	Ramp XSlope (%)	3.6
			N/A	Flare Type LT	N/A	N/A	Flare Type RT	N/A
			N/A	Flare Slope LT (%)	N/A	N/A	Flare Slope RT (%)	N/A
			N/A	Flare Traversable LT?	N/A	N/A	Flare Traversable RT?	N/A
			N/A	Landing Length (in)	N/A	N/A	DWS Provided?	N/A
			N/A	Landing Width (in)	N/A	N/A	DWS Contrast?	N/A
			N/A	Landing Slope (%)	N/A	N/A	DWS Length (in)	N/A
			N/A	Landing X Slope (%)	N/A	N/A	DWS Full Width?	N/A
			N/A	Landing Curb? (Y/N)	N/A	N/A	DWS Offset (in)	N/A
Surveyor Notes: N/A			N/A	Shared Landing?	N/A			
			N/A	Gutter Ponding?	N/A	N/A	Gutter Slope (%)	N/A
			N/A	Gutter Lip Ht (in)	1.0	N/A	Gutter X Slope (%)	N/A
			N/A	Painted X Walk1?	No	N/A	Painted X Walk2?	N/A
				X Walk 1 Direction	To SE		X Walk 2 Direction	N/A
			N/A	X Walk 1 Width (in)	N/A	N/A	X Walk 2 Width (in)	N/A

X Walk 1 Slope (%)	0.4		X Walk 2 Slope (%)	N/A
				X Walk 1 X Slope (%)	4.2		X Walk 2 X Slope (%)	N/A
			N/A	Ramp inside XWalk1?	N/A	N/A	Ramp inside XWalk2?	N/A
				Road Slope (%)	N/A	N/A	Clear Space?	N/A
PROW/ADA: R304.2.2, R304.5.3				Road X Slope (%)	N/A	N/A	Clear Space to XWalk (in)	N/A
			N/A	Any Obstructions?	N/A	N/A	Storm Grate/Utility Hazard?	N/A
				Obstruction Type			Storm Grate/Utility Type	
					N/A			N/A
						Yes	Surface Condition? (G/P)	Good
Total Cost:			\$	1850.00

Remove & Replace Entire Ramp.
