Access Compliance Report

Public Rights-of-Way

(Curb Ramps)

Intersection ID: 44909	Main Street: PALUSTRIS_CT	Cross Street: OAKBURN_DR	Location: SE
ADA ID: 1F3BAB4EC88F	Ramp Type: PerpDiag	Initial Pass/Fail: Fail	Overall Compliance: No
			Severity Score: 46.25

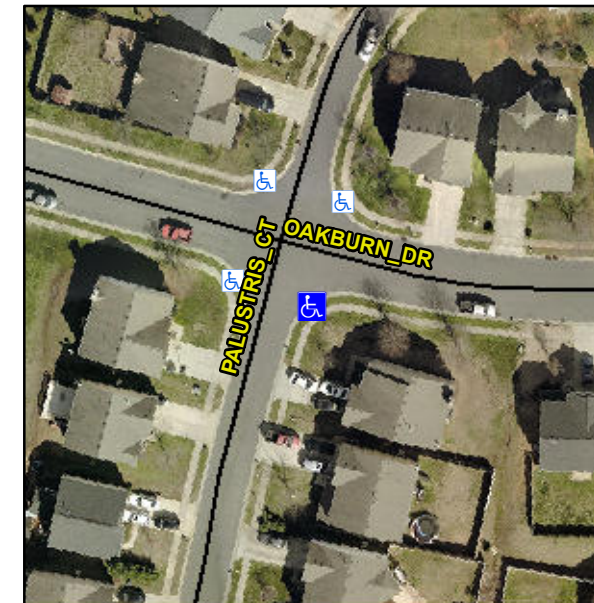
Not Found, R304.5.1, R304.2.2, R304.5.3

Compliance	Description	Data	Compliance	Description	Data
N/A	Ramp Length (in)	47.0	No	Ramp Slope (%)	15.1
No	Ramp Width (in)	44.5	No	Ramp XSlope (%)	5.2
N/A	Flare Type LT	N/A	N/A	Flare Type RT	N/A
N/A	Flare Slope LT (%)	N/A	N/A	Flare Slope RT (%)	N/A
N/A	Flare Traversable LT?	N/A	N/A	Flare Traversable RT?	N/A
N/A	Landing Length (in)	N/A	N/A	DWS Provided?	N/A
N/A	Landing Width (in)	N/A	N/A	DWS Contrast?	N/A
N/A	Landing Slope (%)	N/A	N/A	DWS Length (in)	N/A
N/A	Landing X Slope (%)	N/A	N/A	DWS Full Width?	N/A
N/A	Landing Curb? (Y/N)	N/A	N/A	DWS Offset (in)	N/A
N/A	Shared Landing?	N/A			
N/A	Gutter Ponding?	N/A	N/A	Gutter Slope (%)	N/A
N/A	Gutter Lip Ht (in)	N/A	N/A	Gutter X Slope (%)	N/A
N/A	Painted X Walk1?	No	N/A	Painted X Walk2?	No
	X Walk 1 Direction	To NE		X Walk 2 Direction	To NW
N/A	X Walk 1 Width (in)	N/A	N/A	X Walk 2 Width (in)	N/A
	X Walk 1 Slope (%)	3.0		X Walk 2 Slope (%)	4.2
	X Walk 1 X Slope (%)	0.2		X Walk 2 X Slope (%)	5.0

N/A	Ramp inside XWalk1?	N/A	N/A	Ramp inside XWalk2?	N/A
	Road Slope (%)	5.0	N/A	Clear Space?	N/A
	Road X Slope (%)	5.4	N/A	Clear Space to XWalk (in)	N/A
N/A	Any Obstructions?	N/A	N/A	Storm Grate/Utility Hazard?	N/A
	Obstruction Type			Storm Grate/Utility Type	
		N/A			N/A
			Yes	Surface Condition? (G/P)	Good

Remove & Replace Curb Ramp With Two New Directional Ramps or Equivalent.
