Intersection ID: 9289	Main Street: CONDON_ST	Cross Street: RENNER_ST	Location:	SW
ADA ID: 1F41B97EE322	Ramp Type: Perp	Initial Pass/Fail: Fail	Overall Compliance: No	Severity Score: 1.25

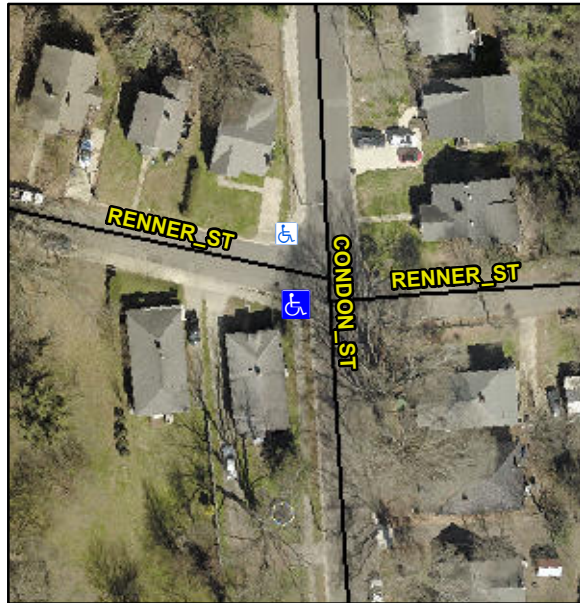
Possible Solutions:			Compliance	Description	Data	Compliance	Description	Data
<b>Remove &amp; Replace Entire Ramp.</b>			N/A	Ramp Length (in)	30.0	Yes	Ramp Slope (%)	8.0
			Yes	Ramp Width (in)	48.0	No	Ramp XSlope (%)	2.5
			N/A	Flare Type LT	N/A	N/A	Flare Type RT	N/A
			N/A	Flare Slope LT (%)	N/A	N/A	Flare Slope RT (%)	N/A
			N/A	Flare Traversable LT?	N/A	N/A	Flare Traversable RT?	N/A
			N/A	Landing Length (in)	N/A	N/A	DWS Provided?	N/A
			N/A	Landing Width (in)	N/A	N/A	DWS Contrast?	N/A
			N/A	Landing Slope (%)	N/A	N/A	DWS Length (in)	N/A
			N/A	Landing X Slope (%)	N/A	N/A	DWS Full Width?	N/A
			N/A	Landing Curb? (Y/N)	N/A	N/A	DWS Offset (in)	N/A
Surveyor Notes:  <b>N/A</b>			N/A	Shared Landing?	N/A			
			N/A	Gutter Ponding?	N/A	N/A	Gutter Slope (%)	N/A
			N/A	Gutter Lip Ht (in)	N/A	N/A	Gutter X Slope (%)	N/A
			N/A	Painted X Walk1?	No	N/A	Painted X Walk2?	N/A
				X Walk 1 Direction	To NE		X Walk 2 Direction	N/A

N/A	X Walk 1 Width (in)	N/A	N/A	X Walk 2 Width (in)	N/A
				X Walk 1 Slope (%)	0.2		X Walk 2 Slope (%)	N/A
				X Walk 1 X Slope (%)	1.2		X Walk 2 X Slope (%)	N/A
			N/A	Ramp inside XWalk1?	N/A	N/A	Ramp inside XWalk2?	N/A
				Road Slope (%)	N/A	N/A	Clear Space?	N/A
PROW/ADA:  <b>Not Found, R304.5.3</b>				Road X Slope (%)	N/A	N/A	Clear Space to XWalk (in)	N/A
			N/A	Any Obstructions?	N/A	N/A	Storm Grate/Utility Hazard?	N/A
				Obstruction Type			Storm Grate/Utility Type	
					N/A			N/A
						Yes	Surface Condition? (G/P)	Good
Total Cost:			\$	1850.00

### Remove & Replace Entire Ramp.
