# Access Compliance Report

## Public Rights-of-Way

### (Curb Ramps)

Intersection ID: 45828	Main Street: CHRISTENBURY_HILLS_LN	Cross Street: GRAYS_RIDGE_DR	Location: SE
ADA ID: 1F47D9C71199	Ramp Type: Perp	Initial Pass/Fail: Fail	Overall Compliance: No
Severity Score: 46.25			
Codes/Mitigation Info/Possible Solution		Field Measurements/Component Compliance

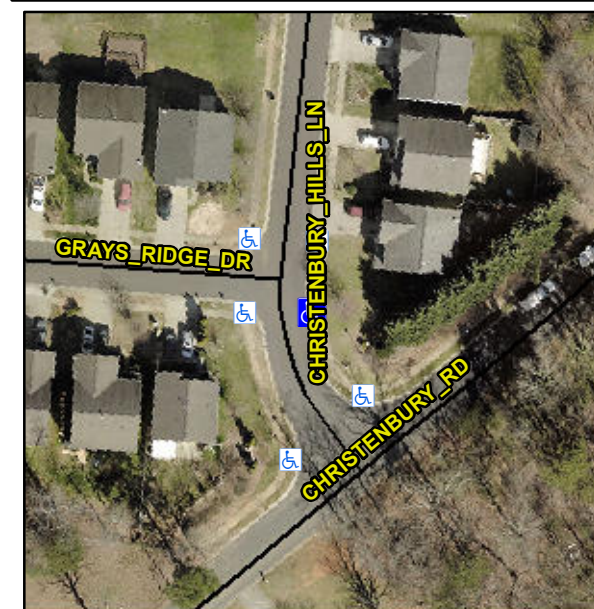
Compliance	Description	Data	Compliance	Description	Data
N/A	Ramp Length (in)	48.0	No	Ramp Slope (%)	12.9
No	Ramp Width (in)	47.0	No	Ramp XSlope (%)	5.3
N/A	Flare Type LT	N/A	N/A	Flare Type RT	N/A
N/A	Flare Slope LT (%)	N/A	N/A	Flare Slope RT (%)	N/A
N/A	Flare Traversable LT?	N/A	N/A	Flare Traversable RT?	N/A
N/A	Landing Length (in)	N/A	N/A	DWS Provided?	N/A
N/A	Landing Width (in)	N/A	N/A	DWS Contrast?	N/A
N/A	Landing Slope (%)	N/A	N/A	DWS Length (in)	N/A
N/A	Landing X Slope (%)	N/A	N/A	DWS Full Width?	N/A
N/A	Landing Curb? (Y/N)	N/A	N/A	DWS Offset (in)	N/A
N/A	Shared Landing?	N/A			
N/A	Gutter Ponding?	N/A	N/A	Gutter Slope (%)	N/A
N/A	Gutter Lip Ht (in)	N/A	N/A	Gutter X Slope (%)	N/A
N/A	Painted X Walk1?	No	N/A	Painted X Walk2?	N/A
	X Walk 1 Direction	To W		X Walk 2 Direction	N/A
N/A	X Walk 1 Width (in)	N/A	N/A	X Walk 2 Width (in)	N/A
	X Walk 1 Slope (%)	1.9		X Walk 2 Slope (%)	N/A
	X Walk 1 X Slope (%)	4.5		X Walk 2 X Slope (%)	N/A

N/A	Ramp inside XWalk1?	N/A	N/A	Ramp inside XWalk2?	N/A
	Road Slope (%)	N/A	N/A	Clear Space?	N/A
	Road X Slope (%)	N/A	N/A	Clear Space to XWalk (in)	N/A
N/A	Any Obstructions?	N/A	N/A	Storm Grate/Utility Hazard?	N/A
	Obstruction Type			Storm Grate/Utility Type	
		N/A			N/A
			Yes	Surface Condition? (G/P)	Good

**Remove & Replace Entire Ramp.**
