Access Compliance Report

Public Rights-of-Way

(Curb Ramps)

Intersection ID: 16392		Main Street: QUEENS_RD_WEST		Cross Street: WELLESLEY_AV		Location: SE											
ADA ID: 1F4CDBBAB3CC		Ramp Type: Directional1		Initial Pass/Fail: Fail		Overall Compliance: No		Severity Score: 1.25									
Codes/Mitigation Info/Possible Solution				Field Measurements/Component Compliance													
<div>

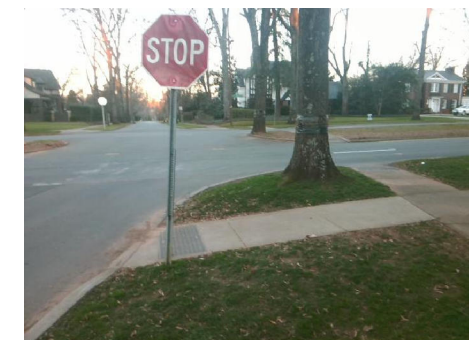
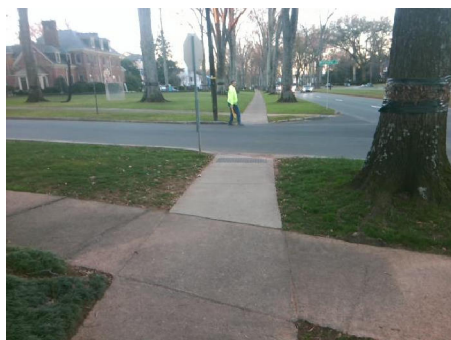
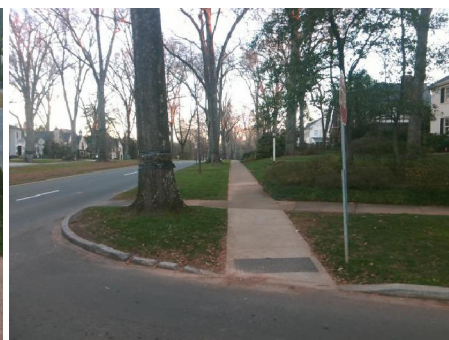
X Walk 1 X Slope (%)		0.3		N/A		Storm Grate/Utility Hazard?		N/A			
				N/A		Ramp inside XWalk1?		N/A				Storm Grate/Utility Type					
				N/A		Any Obstructions?		N/A						N/A			
						Obstruction Type				Yes		Surface Condition? (G/P)		Good			
										N/A		N/A		Curb Slope (%)		7.1

</div> <div>Street 1 NameWELLESLEY AV</div> <div>Stop Condition-Street 1StopSign</div> <div>Street 2 NameN/A</div> <div>Stop Condition-Street 2N/A</div> <div>Possible Solutions: Remove & Replace Entire Ramp.</div> <div>Surveyor Notes: N/A</div> <div>PROW/ADA: R304.5.3</div> <div>Total Cost:\$ 1600.00</div>				Compliance		Description		Data		Compliance		Description		Data			
				N/A		Ramp Length (in)		168.0		N/A		Grade Break?		N/A			
				Yes		Ramp Width (in)		57.0		N/A		Grade Break Slope (%)		0.0			
				Yes		Ramp Slope (%)		5.5		N/A		Grade Break XSlope (%)		0.0			
				No		Ramp XSlope (%)		2.8
