# Access Compliance Report

## Public Rights-of-Way

### (Curb Ramps)

| Intersection ID: 32245 | Main Street: BALMORAL_PARK_DR | Cross Street: OXFORD_COMMONS_DR | Location: | N |

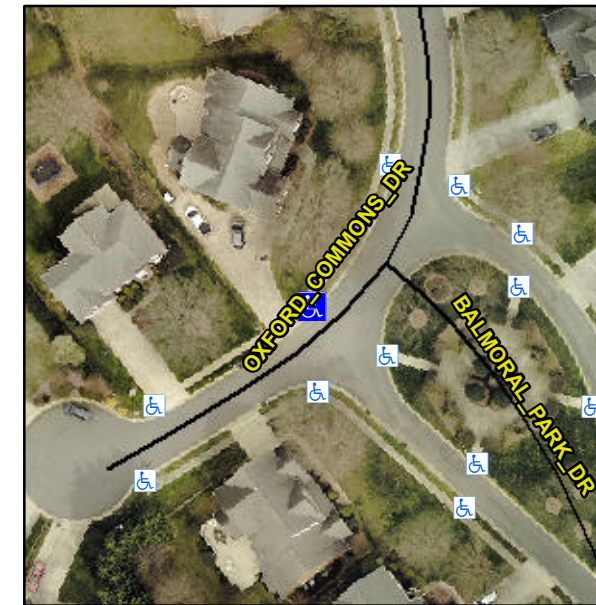
| ADA ID: 1F4D52B4235E | Ramp Type: Perp | Initial Pass/Fail: Fail | Overall Compliance: No | Severity Score: 22.5 |

**Not Found, R304.5.1, R304.2.2**

| Compliance | Description | Data | Compliance | Description | Data |
|---|---|---|---|---|---|
| N/A | Ramp Length (in) | 46.0 | No | Ramp Slope (%) | 11.7 |
| No | Ramp Width (in) | 47.0 | Yes | Ramp XSlope (%) | 3.8 |

**Remove & Replace Entire Ramp.**

Total Cost: \$ 1850.00
