# Access Compliance Report

## Public Rights-of-Way

### (Curb Ramps)

Intersection ID: 8183	Main Street: DR_WEBBER_AV	Cross Street: IRMA_ST	Location: SW
ADA ID: 1F63330FAAD6	Ramp Type: Perp	Initial Pass/Fail: Fail	Overall Compliance: No
Severity Score: 46.25			
Codes/Mitigation Info/Possible Solution		Field Measurements/Component Compliance

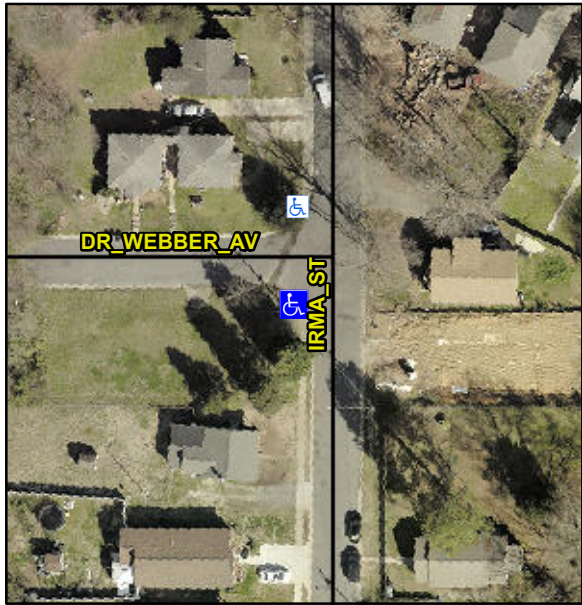
Possible Solutions:		Compliance		Description		Data	Compliance		Description		Data
	Remove & Replace Entire Ramp.		N/A	Ramp Length (in)	51.0	No	Ramp Slope (%)	9.8				
			No	Ramp Width (in)	42.5	No	Ramp XSlope (%)	8.9				
			N/A	Flare Type LT	N/A	N/A	Flare Type RT	N/A				
			N/A	Flare Slope LT (%)	N/A	N/A	Flare Slope RT (%)	N/A				
			N/A	Flare Traversable LT?	N/A	N/A	Flare Traversable RT?	N/A				
			N/A	Landing Length (in)	N/A	N/A	DWS Provided?	N/A				
			N/A	Landing Width (in)	N/A	N/A	DWS Contrast?	N/A				
			N/A	Landing Slope (%)	N/A	N/A	DWS Length (in)	N/A				
			N/A	Landing X Slope (%)	N/A	N/A	DWS Full Width?	N/A				
Surveyor Notes:		N/A	N/A	Landing Curb? (Y/N)	N/A	N/A	DWS Offset (in)	N/A				
		N/A	Shared Landing?	N/A								
PROW/ADA:		N/A	N/A	Gutter Ponding?	N/A	N/A	Gutter Slope (%)	N/A				
		Not Found, R304.5.1, R304.2.2, R304.5.3	N/A	Gutter Lip Ht (in)	N/A	N/A	Gutter X Slope (%)	N/A				
			N/A	Painted X Walk1?	No	N/A	Painted X Walk2?	N/A

X Walk 1 Direction	To N		X Walk 2 Direction	N/A				
			N/A	X Walk 1 Width (in)	N/A	N/A	X Walk 2 Width (in)	N/A				
				X Walk 1 Slope (%)	7.5		X Walk 2 Slope (%)	N/A				
				X Walk 1 X Slope (%)	1.0		X Walk 2 X Slope (%)	N/A				
			N/A	Ramp inside XWalk1?	N/A	N/A	Ramp inside XWalk2?	N/A				
				Road Slope (%)	N/A	N/A	Clear Space?	N/A				
				Road X Slope (%)	N/A	N/A	Clear Space to XWalk (in)	N/A				
			N/A	Any Obstructions?	N/A	N/A	Storm Grate/Utility Hazard?	N/A				
				Obstruction Type			Storm Grate/Utility Type					
					N/A			N/A				
						Yes	Surface Condition? (G/P)	Good				
Street 1 Name		DR WEBBER AV										
Stop Condition-Street 2		StopSign										
Street 2 Name		N/A										
Stop Condition-Street 1		N/A										
Total Cost:		\$	1850.00

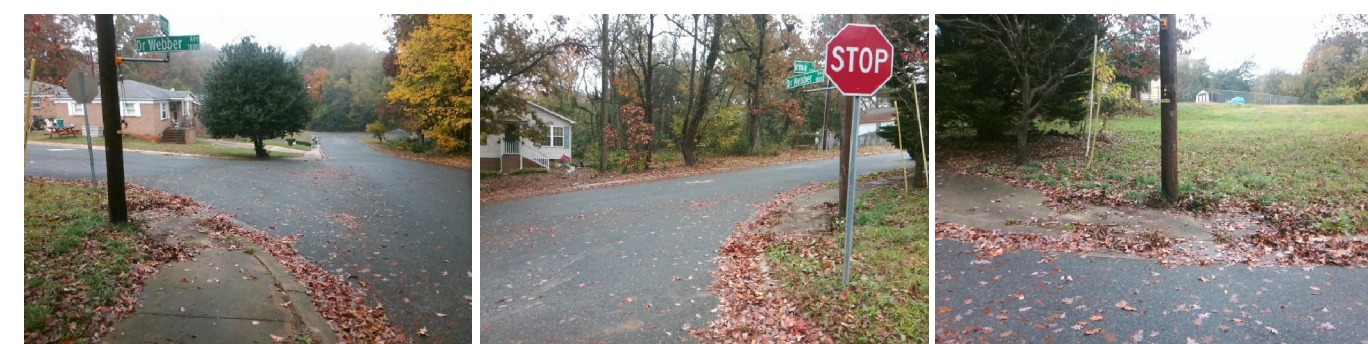
Compliance	Description	Data	Compliance	Description	Data
N/A	Ramp Length (in)	51.0	No	Ramp Slope (%)	9.8
No	Ramp Width (in)	42.5	No	Ramp XSlope (%)	8.9
N/A	Flare Type LT	N/A	N/A	Flare Type RT	N/A
N/A	Flare Slope LT (%)	N/A	N/A	Flare Slope RT (%)	N/A
N/A	Flare Traversable LT?	N/A	N/A	Flare Traversable RT?	N/A
N/A	Landing Length (in)	N/A	N/A	DWS Provided?	N/A
N/A	Landing Width (in)	N/A	N/A	DWS Contrast?	N/A
N/A	Landing Slope (%)	N/A	N/A	DWS Length (in)	N/A
N/A	Landing X Slope (%)	N/A	N/A	DWS Full Width?	N/A
N/A	Landing Curb? (Y/N)	N/A	N/A	DWS Offset (in)	N/A
N/A	Shared Landing?	N/A			
N/A	Gutter Ponding?	N/A	N/A	Gutter Slope (%)	N/A
N/A	Gutter Lip Ht (in)	N/A	N/A	Gutter X Slope (%)	N/A
N/A	Painted X Walk1?	No	N/A	Painted X Walk2?	N/A
	X Walk 1 Direction	To N		X Walk 2 Direction	N/A
N/A	X Walk 1 Width (in)	N/A	N/A	X Walk 2 Width (in)	N/A
	X Walk 1 Slope (%)	7.5		X Walk 2 Slope (%)	N/A
	X Walk 1 X Slope (%)	1.0		X Walk 2 X Slope (%)	N/A

N/A	Ramp inside XWalk1?	N/A	N/A	Ramp inside XWalk2?	N/A
	Road Slope (%)	N/A	N/A	Clear Space?	N/A
	Road X Slope (%)	N/A	N/A	Clear Space to XWalk (in)	N/A
N/A	Any Obstructions?	N/A	N/A	Storm Grate/Utility Hazard?	N/A
	Obstruction Type			Storm Grate/Utility Type	
		N/A			N/A
			Yes	Surface Condition? (G/P)	Good
