Access Compliance Report

Public Rights-of-Way

(Curb Ramps)

Intersection ID: 49801	Main Street: PARSIFAL_LN	Cross Street: GANDOLFO_CT	Location:	N
ADA ID: 1F705A6B78CC	Ramp Type: PerpDiag	Initial Pass/Fail: Fail	Overall Compliance: No	Severity Score: 46.25
Codes/Mitigation Info/Possible Solution		Field Measurements/Component Compliance

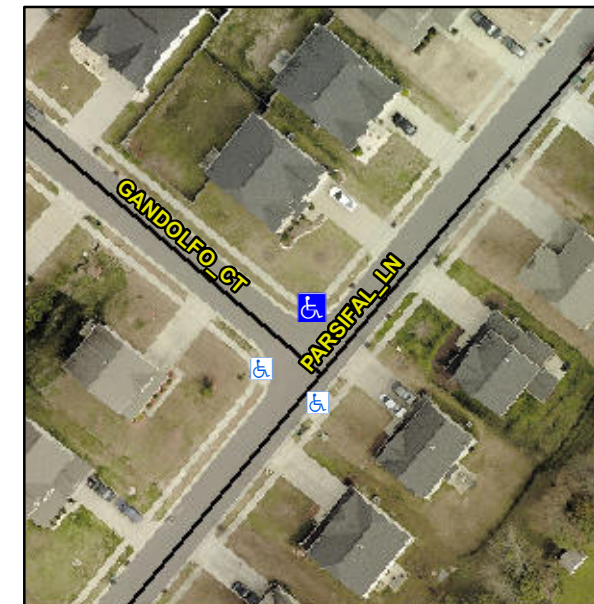
Not Found, R304.5.1, R304.2.2, R304.5.3

Compliance	Description	Data	Compliance	Description	Data
N/A	Ramp Length (in)	48.0	No	Ramp Slope (%)	12.6
No	Ramp Width (in)	47.0	No	Ramp XSlope (%)	5.1
N/A	Flare Type LT	N/A	N/A	Flare Type RT	N/A
N/A	Flare Slope LT (%)	N/A	N/A	Flare Slope RT (%)	N/A
N/A	Flare Traversable LT?	N/A	N/A	Flare Traversable RT?	N/A
N/A	Landing Length (in)	N/A	N/A	DWS Provided?	N/A
N/A	Landing Width (in)	N/A	N/A	DWS Contrast?	N/A
N/A	Landing Slope (%)	N/A	N/A	DWS Length (in)	N/A
N/A	Landing X Slope (%)	N/A	N/A	DWS Full Width?	N/A
N/A	Landing Curb? (Y/N)	N/A	N/A	DWS Offset (in)	N/A
N/A	Shared Landing?	N/A			
N/A	Gutter Ponding?	N/A	N/A	Gutter Slope (%)	N/A
N/A	Gutter Lip Ht (in)	N/A	N/A	Gutter X Slope (%)	N/A
N/A	Painted X Walk1?	No	N/A	Painted X Walk2?	No
	X Walk 1 Direction	To SW		X Walk 2 Direction	To SE
N/A	X Walk 1 Width (in)	N/A	N/A	X Walk 2 Width (in)	N/A
	X Walk 1 Slope (%)	3.2		X Walk 2 Slope (%)	N/A
	X Walk 1 X Slope (%)	4.2		X Walk 2 X Slope (%)	N/A

N/A	Ramp inside XWalk1?	N/A	N/A	Ramp inside XWalk2?	N/A
	Road Slope (%)	4.2	N/A	Clear Space?	N/A
	Road X Slope (%)	1.4	N/A	Clear Space to XWalk (in)	N/A
N/A	Any Obstructions?	N/A	N/A	Storm Grate/Utility Hazard?	N/A
	Obstruction Type			Storm Grate/Utility Type	
		N/A			N/A
			Yes	Surface Condition? (G/P)	Good

Possible Solutions:

Remove & Replace Curb Ramp With Two New Directional Ramps or Equivalent.
