# Access Compliance Report

## Public Rights-of-Way

### (Curb Ramps)

Intersection ID: 53517	Main Street: STONEWELLS_DR	Cross Street: KINGAUSSIE_AV	Location: NW
ADA ID: 1F71A27B0236	Ramp Type: BlendTrans1	Initial Pass/Fail: Fail	Overall Compliance: No
		Severity Score: 1.25

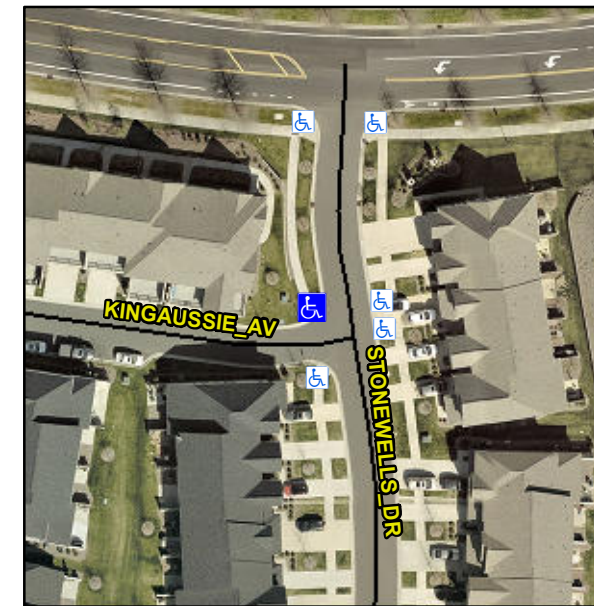
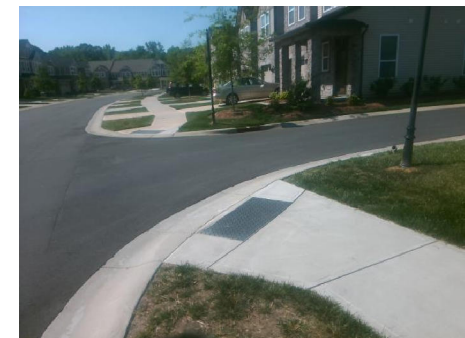
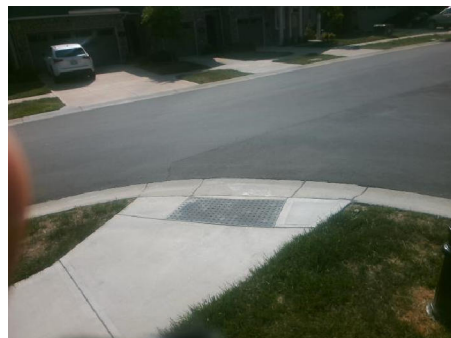
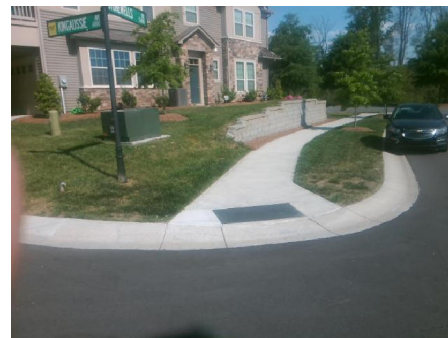
**Not Found, R304.5.3, R304.4.1**

Compliance	Description	Data	Compliance	Description	Data
N/A	Ramp Length (in)	55.0	No	BlendTrans Slope (%)	6.6
Yes	Ramp Width (in)	48.0	No	BlendTrans XSlope (%)	2.9
N/A	Flare Type LT	N/A	N/A	Flare Type RT	N/A
N/A	Flare Slope LT (%)	N/A	N/A	Flare Slope RT (%)	N/A
N/A	Flare Traversable LT?	N/A	N/A	Flare Traversable RT?	N/A
N/A	Landing Length (in)	N/A	N/A	DWS Provided?	N/A
N/A	Landing Width (in)	N/A	N/A	DWS Contrast?	N/A
N/A	Landing Slope (%)	N/A	N/A	DWS Length (in)	N/A
N/A	Landing X Slope (%)	N/A	N/A	DWS Full Width?	N/A
N/A	Landing Curb? (Y/N)	N/A	N/A	DWS Offset (in)	N/A
N/A	Shared Landing?	N/A			
N/A	Gutter Ponding?	N/A	N/A	Gutter Slope (%)	N/A
N/A	Gutter Lip Ht (in)	N/A	N/A	Gutter X Slope (%)	N/A
N/A	Painted X Walk1?	No	N/A	Painted X Walk2?	No
	X Walk 1 Direction	To E		X Walk 2 Direction	To S
	X Walk 1 Width (in)	N/A		X Walk 2 Width (in)	N/A
	X Walk 1 Slope (%)	0.2		X Walk 2 Slope (%)	0.3
	X Walk 1 X Slope (%)	4.0		X Walk 2 X Slope (%)	2.9

N/A	Ramp inside XWalk1?	N/A	N/A	Ramp inside XWalk2?	N/A
	Road Slope (%)	4.0		Clear Space?	N/A
	Road X Slope (%)	0.1	N/A	Clear Space to XWalk (in)	N/A
N/A	Any Obstructions?	N/A	N/A	Storm Grate/Utility Hazard?	N/A
	Obstruction Type			Storm Grate/Utility Type	
		N/A			N/A
			Yes	Surface Condition? (G/P)	Good
			No	Curb Slope (%)	9.4

**Remove & Replace Curb Ramp With Two New Directional Ramps or Equivalent.**
