Access Compliance Report Public Rights-of-Way (Curb Ramps)

Intersection ID: 47279 Main Street: SAVANNAH HILLS DR **Cross Street: CARRINGTON FOREST LN** Location: SE ADA ID: 1F7941D15730 Ramp Type: BlendTrans1 Initial Pass/Fail: Fail **Overall Compliance: No Severity Score:** 8.75

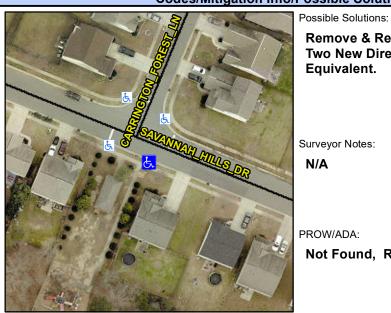
Not Found, R304.5.1

Field Measurements/Component Compliance						
Compliance Description		Data	Comp	liance Description	Data	
N/A	Ramp Length (in)	48.0	Yes	BlendTrans Slope (%)	4.4	
No	Ramp Width (in)	43.0	Yes	BlendTrans XSlope (%)	0.3	
N/A	Flare Type LT	N/A	N/A	Flare Type RT	N/A	
N/A	Flare Slope LT (%)	N/A	N/A	Flare Slope RT (%)	N/A	
N/A	Flare Traversable LT?	N/A	N/A	Flare Traversable RT?	N/A	
N/A	Landing Length (in)	N/A	N/A	DWS Provided?	N/A	
N/A	Landing Width (in)	N/A	N/A	DWS Contrast?	N/A	
N/A	Landing Slope (%)	N/A	N/A	DWS Length (in)	N/A	
N/A	Landing X Slope (%)	N/A	N/A	DWS Full Width?	N/A	
N/A	Landing Curb? (Y/N)	N/A	N/A	DWS Offset (in)	N/A	
N/A	Shared Landing?	N/A				
N/A	Gutter Ponding?	N/A	N/A	Gutter Slope (%)	N/A	
N/A	Gutter Lip Ht (in)	N/A	N/A	Gutter X Slope (%)	N/A	
N/A	Painted X Walk1?	No	N/A	Painted X Walk2?	N/A	
	X Walk 1 Direction	To N		X Walk 2 Direction	N/A	
	X Walk 1 Width (in)	N/A		X Walk 2 Width (in)	N/A

X Walk 1 Slope (%)	5.5		X Walk 2 Slope (%)	N/A	
	X Walk 1 X Slope (%)	1.7		X Walk 2 X Slope (%)	N/A	
N/A	Ramp inside XWalk1?	N/A	N/A	Ramp inside XWalk2?	N/A	
	Road Slope (%)	1.7		Clear Space?	N/A	
	Road X Slope (%)	5.5	N/A	Clear Space to XWalk (in)	N/A	
N/A	Any Obstructions?	N/A	N/A	Storm Grate/Utility Hazard?	N/A	
	Obstruction Type		l	Storm Grate/Utility Type		
		N/A			N/A	
			Yes	Surface Condition? (G/P)	Good	
			No	Curb Slope (%)	10.7

SAVANNAH HILLS DR Street 1 Name Stop Condition-Street 1 None Street 2 Name N/A Stop Condition-Street 2 N/A **Remove & Replace Curb Ramp With Two New Directional Ramps or** Equivalent.
