Access Compliance Report

Public Rights-of-Way

(Curb Ramps)

Intersection ID: 12521	Main Street: BELVEDERE_AV	Cross Street: CHATHAM_AV	Location: SE
ADA ID: 1F838206E55B	Ramp Type: Perp	Initial Pass/Fail: Fail	Overall Compliance: No
Severity Score: 21.25			
Codes/Mitigation Info/Possible Solution		Field Measurements/Component Compliance

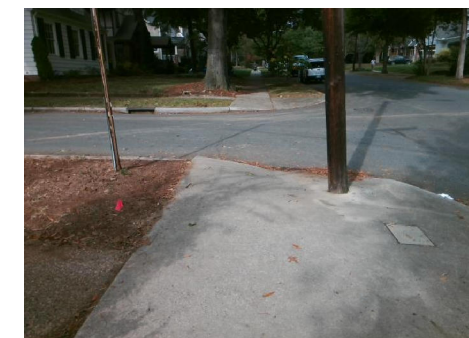
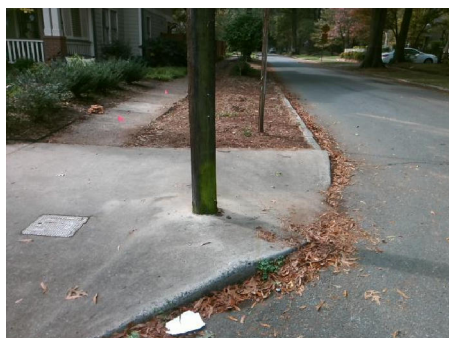
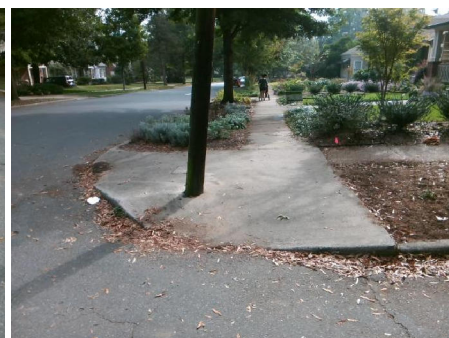
Compliance	Description	Data	Compliance	Description	Data
N/A	Ramp Length (in)	47.0	Yes	Ramp Slope (%)	8.1
No	Ramp Width (in)	42.0	No	Ramp XSlope (%)	5.2
N/A	Flare Type LT	N/A	N/A	Flare Type RT	N/A
N/A	Flare Slope LT (%)	N/A	N/A	Flare Slope RT (%)	N/A
N/A	Flare Traversable LT?	N/A	N/A	Flare Traversable RT?	N/A
N/A	Landing Length (in)	N/A	N/A	DWS Provided?	N/A
N/A	Landing Width (in)	N/A	N/A	DWS Contrast?	N/A
N/A	Landing Slope (%)	N/A	N/A	DWS Length (in)	N/A
N/A	Landing X Slope (%)	N/A	N/A	DWS Full Width?	N/A
N/A	Landing Curb? (Y/N)	N/A	N/A	DWS Offset (in)	N/A
N/A	Shared Landing?	N/A			
N/A	Gutter Ponding?	Yes	N/A	Gutter Slope (%)	N/A
N/A	Gutter Lip Ht (in)	N/A	N/A	Gutter X Slope (%)	N/A
N/A	Painted X Walk1?	No	N/A	Painted X Walk2?	N/A
	X Walk 1 Direction	To W		X Walk 2 Direction	N/A
N/A	X Walk 1 Width (in)	N/A	N/A	X Walk 2 Width (in)	N/A
	X Walk 1 Slope (%)	5.1		X Walk 2 Slope (%)	N/A
	X Walk 1 X Slope (%)	0.6		X Walk 2 X Slope (%)	N/A

N/A	Ramp inside XWalk1?	N/A	N/A	Ramp inside XWalk2?	N/A
	Road Slope (%)	N/A	N/A	Clear Space?	N/A
	Road X Slope (%)	N/A	N/A	Clear Space to XWalk (in)	N/A
N/A	Any Obstructions?	N/A	N/A	Storm Grate/Utility Hazard?	N/A
	Obstruction Type			Storm Grate/Utility Type	
		N/A			N/A
		Yes		Surface Condition? (G/P)	Good

Remove & Replace Entire Ramp.
