Access Compliance Report

Public Rights-of-Way

(Curb Ramps)

Intersection ID: 45764	Main Street: CHRISTENBURY_RD	Cross Street: GREENOCK_RIDGE_CT	Location: E
ADA ID: 1F875B0B9894	Ramp Type: PerpDiag	Initial Pass/Fail: Fail	Overall Compliance: No
Severity Score: 22.5			
Codes/Mitigation Info/Possible Solution		Field Measurements/Component Compliance

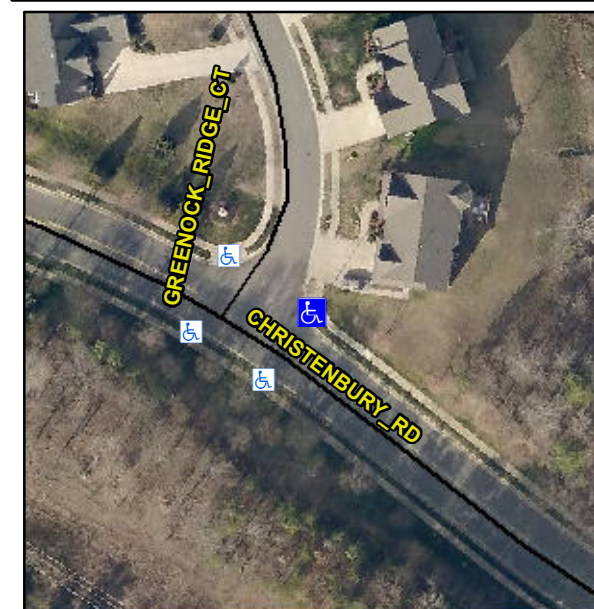
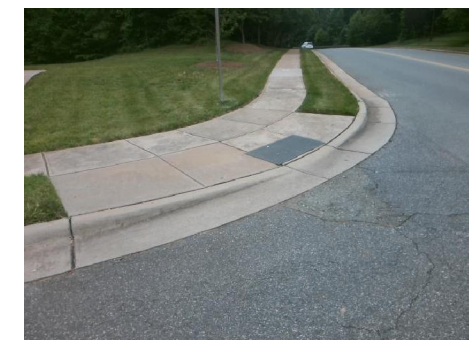
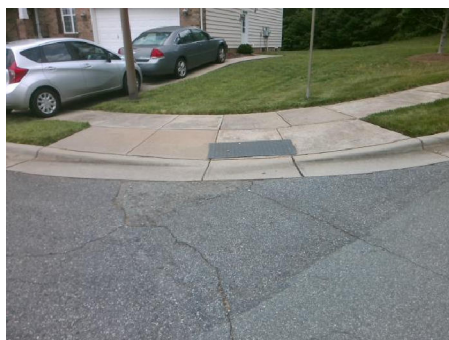
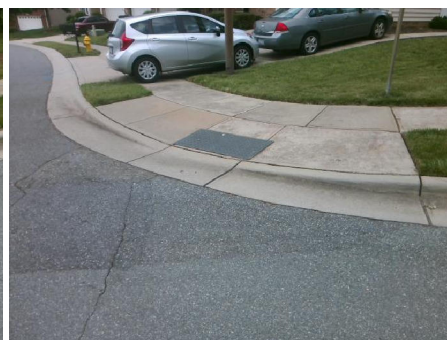
Compliance	Description	Data	Compliance	Description	Data
N/A	Ramp Length (in)	50.0	No	Ramp Slope (%)	10.6
No	Ramp Width (in)	38.0	No	Ramp XSlope (%)	3.5
N/A	Flare Type LT	N/A	N/A	Flare Type RT	N/A
N/A	Flare Slope LT (%)	N/A	N/A	Flare Slope RT (%)	N/A
N/A	Flare Traversable LT?	N/A	N/A	Flare Traversable RT?	N/A
N/A	Landing Length (in)	N/A	N/A	DWS Provided?	N/A
N/A	Landing Width (in)	N/A	N/A	DWS Contrast?	N/A
N/A	Landing Slope (%)	N/A	N/A	DWS Length (in)	N/A
N/A	Landing X Slope (%)	N/A	N/A	DWS Full Width?	N/A
N/A	Landing Curb? (Y/N)	N/A	N/A	DWS Offset (in)	N/A
N/A	Shared Landing?	N/A			
N/A	Gutter Ponding?	N/A	N/A	Gutter Slope (%)	N/A
N/A	Gutter Lip Ht (in)	N/A	N/A	Gutter X Slope (%)	N/A
N/A	Painted X Walk1?	No	N/A	Painted X Walk2?	No
	X Walk 1 Direction	To NW		X Walk 2 Direction	To SW
N/A	X Walk 1 Width (in)	N/A	N/A	X Walk 2 Width (in)	N/A
	X Walk 1 Slope (%)	8.8		X Walk 2 Slope (%)	3.1
	X Walk 1 X Slope (%)	1.9		X Walk 2 X Slope (%)	5.2

N/A	Ramp inside XWalk1?	N/A	N/A	Ramp inside XWalk2?	N/A
	Road Slope (%)	2.6	N/A	Clear Space?	N/A
	Road X Slope (%)	5.5	N/A	Clear Space to XWalk (in)	N/A
N/A	Any Obstructions?	N/A	N/A	Storm Grate/Utility Hazard?	N/A
	Obstruction Type			Storm Grate/Utility Type	
		N/A			N/A
			Yes	Surface Condition? (G/P)	Good

Possible Solutions:

Remove & Replace Curb Ramp With Two New Directional Ramps or Equivalent.

R304.5.1, R304.2.2, R304.5.3
