Access Compliance Report

Public Rights-of-Way

(Curb Ramps)

Intersection ID: 32271	Main Street: SPRINGWELL_ST	Cross Street: SULLIVAN_RIDGE_DR	Location: SE
ADA ID: 1F9A66A30737	Ramp Type: Combination1Diag	Initial Pass/Fail: Fail	Overall Compliance: No
Codes/Mitigation Info/Possible Solution		Field Measurements/Component Compliance	
Severity Score: 0

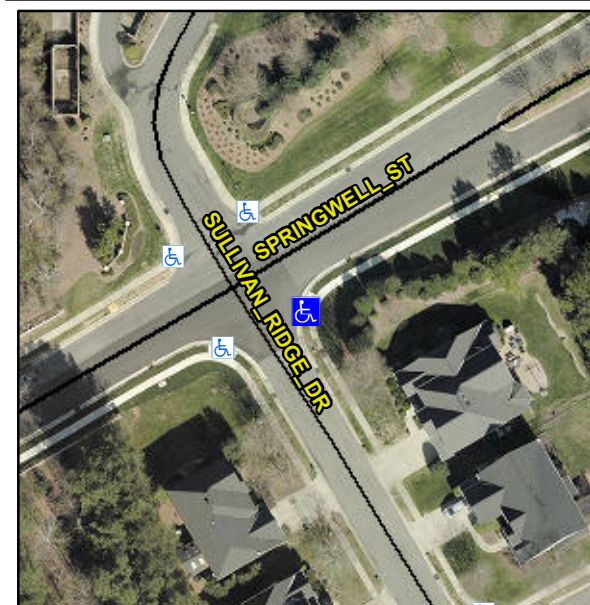
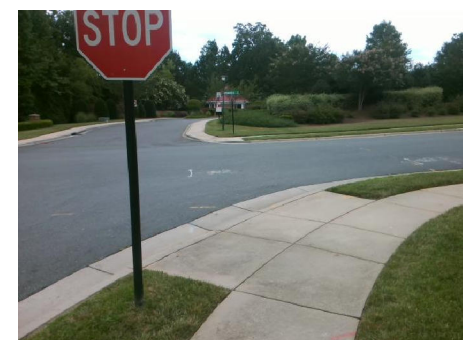
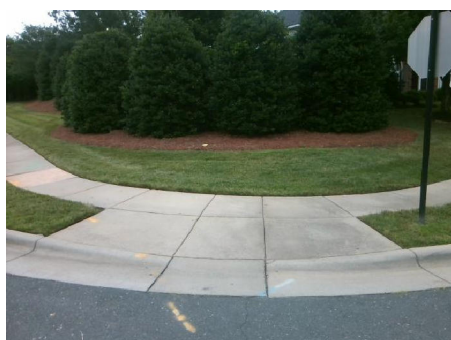
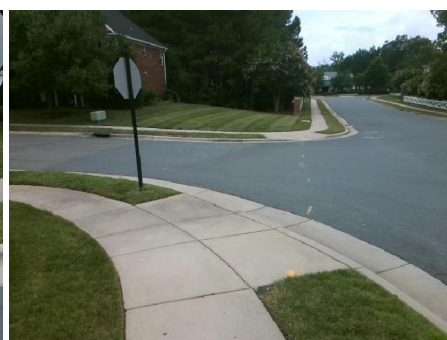
RT RP < 5%

Not Found, R304.5.1, R304.5.1, R304.2.2, R304.5.3

Compliance	Description	Data	Compliance	Description	Data
N/A	Ramp Length LT (in)	52.0	N/A	Ramp Length RT (in)	45.0
No	Ramp Width LT (in)	46.0	No	Ramp Width RT (in)	46.0
Yes	Ramp Slope LT (%)	6.2	Yes	Ramp Slope RT (%)	4.7
No	Ramp XSlope LT (%)	3.7	No	Ramp XSlope RT (%)	3.2
N/A	Ramp Length (in)	58.0	No	Ramp Slope (%)	11.4
No	Ramp Width (in)	39.0	No	Ramp XSlope (%)	4.8
N/A	Flare Type LT	N/A	N/A	Flare Type RT	N/A
N/A	Flare Slope LT (%)	N/A	N/A	Flare Slope RT (%)	N/A
N/A	Flare Traversable LT?	N/A	N/A	Flare Traversable RT?	N/A
N/A	Landing Length (in)	N/A	N/A	DWS Provided?	N/A
N/A	Landing Width (in)	N/A	N/A	DWS Contrast?	N/A
N/A	Landing Slope (%)	N/A	N/A	DWS Length (in)	N/A
N/A	Landing X Slope (%)	N/A	N/A	DWS Full Width?	N/A
N/A	Landing Curb? (Y/N)	N/A	N/A	DWS Offset (in)	N/A
N/A	Shared Landing?	N/A			
N/A	Gutter Ponding?	N/A	N/A	Gutter Slope (%)	N/A
N/A	Gutter Lip Ht (in)	N/A	N/A	Gutter X Slope (%)	N/A
N/A	Painted X Walk1?	No	N/A	Painted X Walk2?	No

X Walk 1 Direction	To NW		X Walk 2 Direction	To SW
	X Walk 1 Width (in)	N/A		X Walk 2 Width (in)	N/A
	X Walk 1 Slope (%)	1.3		X Walk 2 Slope (%)	3.2
	X Walk 1 X Slope (%)	2.3		X Walk 2 X Slope (%)	1.0
N/A	Ramp inside XWalk1?	N/A	N/A	Ramp inside XWalk2?	N/A
	Road Slope (%)	4.3		Clear Space?	N/A
	Road X Slope (%)	0.3	N/A	Clear Space to XWalk (in)	N/A
			N/A	Any Obstruction?	N/A
				Obstruction Type	N/A
			N/A	Storm Grate/Utility Hazard?	N/A
				Storm Grate/Utility Type	N/A
					N/A
Yes	Surface Condition? (G/P)	Good			
	Curb Slope (%)	16.5

Possible Solutions:

Remove & Replace Curb Ramp With Two New Directional Ramps or Equivalent.
