Access Compliance Report

Public Rights-of-Way (Curb Ramps)

Intersection ID: 15205	Main Street: CHEROKEE_RD	Cross Street: FENTON_PL	Location: NW
ADA ID: 1FADB539A8C2	Ramp Type: Directional1	Initial Pass/Fail: Fail	Overall Compliance: No
		Severity Score: 10

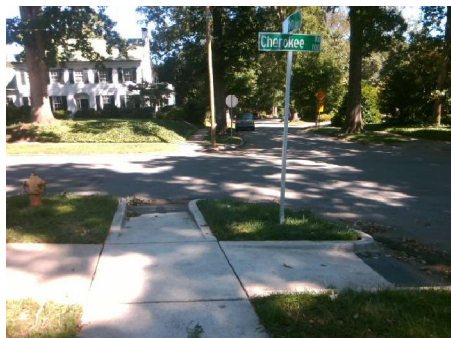
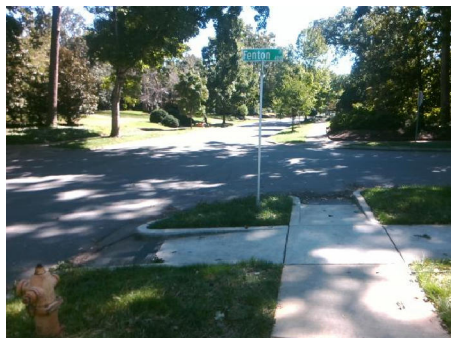
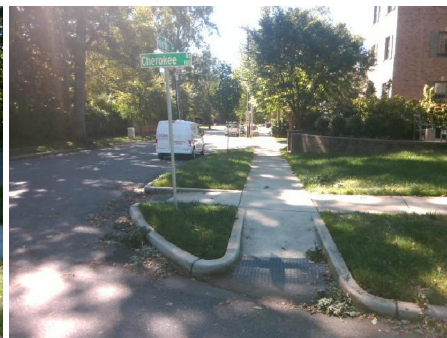
Compliance	Description	Data	Compliance	Description	Data
N/A	Ramp Length (in)	113.0	N/A	Grade Break?	N/A
No	Ramp Width (in)	45.0	N/A	Grade Break Slope (%)	0.0
Yes	Ramp Slope (%)	7.0	N/A	Grade Break XSlope (%)	0.0
No	Ramp XSlope (%)	4.1			
N/A	Flare Type LT	N/A	N/A	Flare Type RT	N/A
N/A	Flare Slope LT (%)	N/A	N/A	Flare Slope RT (%)	0.0
N/A	Flare Traversable LT?	N/A	N/A	Flare Traversable RT?	N/A
N/A	Landing Length (in)	0.0	N/A	DWS Provided?	N/A
N/A	Landing Width (in)	0.0	N/A	DWS Contrast?	N/A
N/A	Landing Slope (%)	0.0	N/A	DWS Length (in)	N/A
N/A	Landing X Slope (%)	0.0	N/A	DWS Full Width?	N/A
N/A	Landing Curb? (Y/N)	N/A	N/A	DWS Offset LT (in)	N/A
N/A	Shared Landing?	N/A	N/A	DWS Offset RT (in)	N/A
N/A	Gutter Ponding?	0.0	N/A	Gutter Slope (%)	N/A
N/A	Gutter Lip Ht (in)	0.0	N/A	Gutter X Slope (%)	N/A
N/A	Painted X Walk1?	No		Road Slope (%)	5.8
	X Walk 1 Direction	To NE		Road X Slope (%)	0.5
	X Walk 1 Width (in)	N/A		Clear Space?	N/A

X Walk 1 Slope (%)	5.8	N/A	Clear Space to XWalk (in)	N/A
	X Walk 1 X Slope (%)	0.5	N/A	Storm Grate/Utility Hazard?	N/A
N/A	Ramp inside XWalk1?	N/A		Storm Grate/Utility Type	
N/A	Any Obstructions?	N/A			N/A
	Obstruction Type		Yes	Surface Condition? (G/P)	Good
			N/A	Curb Slope (%)	9.4

Remove & Replace Entire Ramp.
