# Access Compliance Report

## Public Rights-of-Way

### (Curb Ramps)

Intersection ID: 22591	Main Street: CARMEL_RD	Cross Street: KINGSWOOD_RD	Location: SW
ADA ID: 1FB446119629	Ramp Type: PerpDiag	Initial Pass/Fail: Fail	Overall Compliance: No
		Severity Score: 12.5

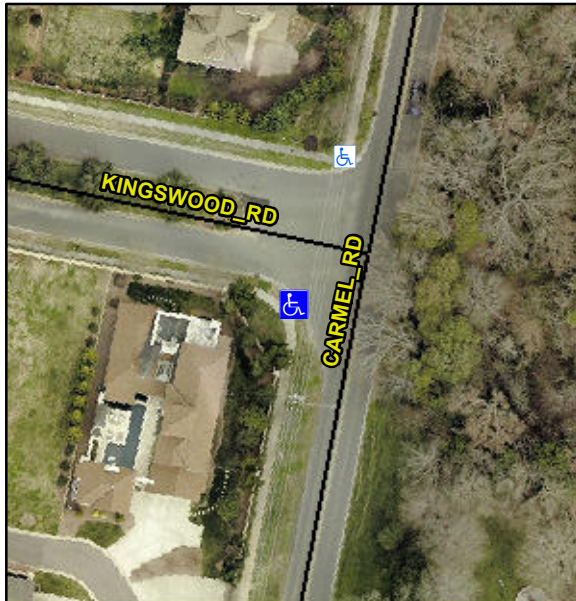
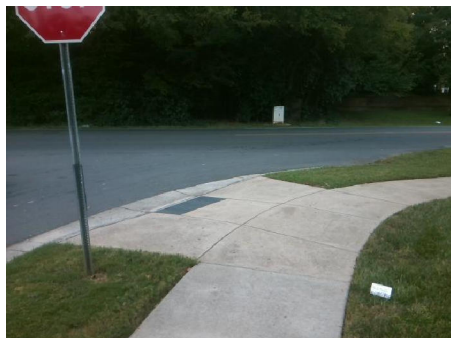
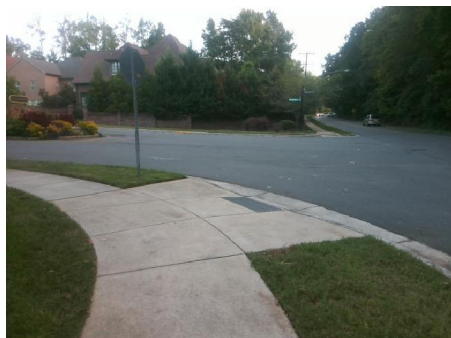
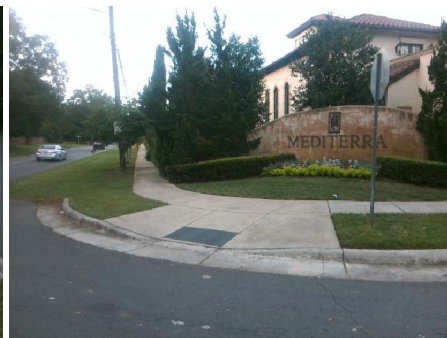
**Not Found, R304.2.2**

Compliance	Description	Data	Compliance	Description	Data
N/A	Ramp Length (in)	70.5	No	Ramp Slope (%)	10.5
Yes	Ramp Width (in)	48.0	Yes	Ramp XSlope (%)	1.8
N/A	Flare Type LT	N/A	N/A	Flare Type RT	N/A
N/A	Flare Slope LT (%)	N/A	N/A	Flare Slope RT (%)	N/A
N/A	Flare Traversable LT?	N/A	N/A	Flare Traversable RT?	N/A
N/A	Landing Length (in)	N/A	N/A	DWS Provided?	N/A
N/A	Landing Width (in)	N/A	N/A	DWS Contrast?	N/A
N/A	Landing Slope (%)	N/A	N/A	DWS Length (in)	N/A
N/A	Landing X Slope (%)	N/A	N/A	DWS Full Width?	N/A
N/A	Landing Curb? (Y/N)	N/A	N/A	DWS Offset (in)	N/A
N/A	Shared Landing?	N/A			
N/A	Gutter Ponding?	N/A	N/A	Gutter Slope (%)	N/A
N/A	Gutter Lip Ht (in)	N/A	N/A	Gutter X Slope (%)	N/A
N/A	Painted X Walk1?	No	N/A	Painted X Walk2?	No
	X Walk 1 Direction	To SE		X Walk 2 Direction	To NE
N/A	X Walk 1 Width (in)	N/A	N/A	X Walk 2 Width (in)	N/A
	X Walk 1 Slope (%)	0.0		X Walk 2 Slope (%)	3.2
	X Walk 1 X Slope (%)	3.3		X Walk 2 X Slope (%)	1.0

N/A	Ramp inside XWalk1?	N/A	N/A	Ramp inside XWalk2?	N/A
	Road Slope (%)	1.5	N/A	Clear Space?	N/A
	Road X Slope (%)	2.3	N/A	Clear Space to XWalk (in)	N/A
N/A	Any Obstructions?	N/A	N/A	Storm Grate/Utility Hazard?	N/A
	Obstruction Type			Storm Grate/Utility Type	
		N/A			N/A
			Yes	Surface Condition? (G/P)	Good

**Remove & Replace Curb Ramp With Two New Directional Ramps or Equivalent.**
