Intersection ID: 10022617	Main Street: CARMEL_RD	Cross Street: N/A	Location:	NE
ADA ID: 1FC2DF903EB6	Ramp Type: Perp	Initial Pass/Fail: Fail	Overall Compliance: No	Severity Score: 13.75

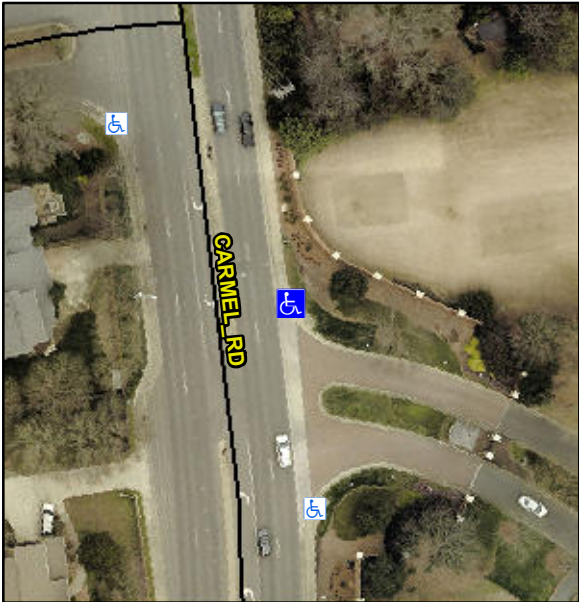
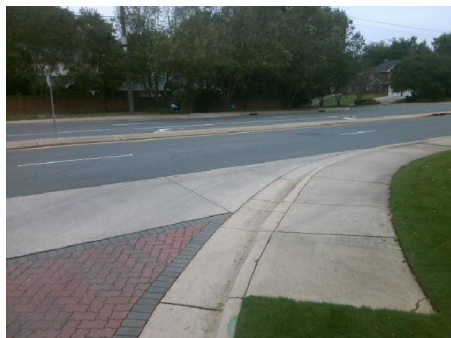
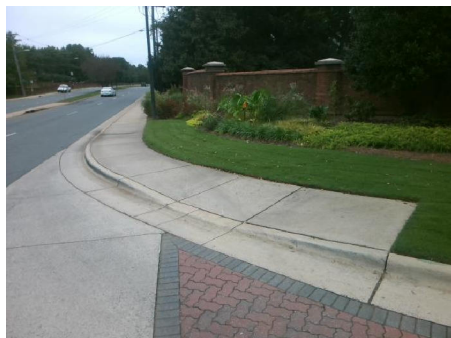
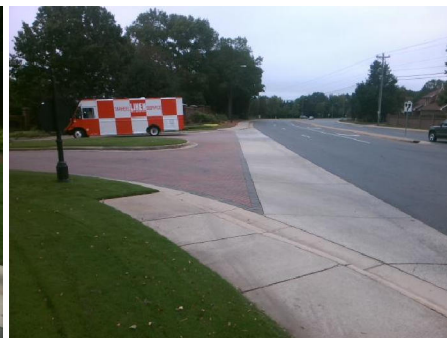
X Walk 1 Direction	To S		X Walk 2 Direction	N/A
			N/A	X Walk 1 Width (in)	N/A	N/A	X Walk 2 Width (in)	N/A
				X Walk 1 Slope (%)	0.1		X Walk 2 Slope (%)	N/A
				X Walk 1 X Slope (%)	0.0		X Walk 2 X Slope (%)	N/A
			N/A	Ramp inside XWalk1?	N/A	N/A	Ramp inside XWalk2?	N/A
				Road Slope (%)	N/A	N/A	Clear Space?	N/A
				Road X Slope (%)	N/A	N/A	Clear Space to XWalk (in)	N/A
			N/A	Any Obstructions?	N/A	N/A	Storm Grate/Utility Hazard?	N/A
				Obstruction Type			Storm Grate/Utility Type	
					N/A			N/A
						Yes	Surface Condition? (G/P)	Good
Street 1 Name	ENTRANCE							
Stop Condition-Street 2	StopSign							
Street 2 Name	N/A							
Stop Condition-Street 1	N/A							
Total Cost:	\$	1850.00

Possible Solutions:	Remove & Replace Entire Ramp.	Compliance	Description	Data	Compliance	Description	Data
			N/A	Ramp Length (in)	57.0	No	Ramp Slope (%)	9.1
			Yes	Ramp Width (in)	50.0	No	Ramp XSlope (%)	2.3
			N/A	Flare Type LT	N/A	N/A	Flare Type RT	N/A
			N/A	Flare Slope LT (%)	N/A	N/A	Flare Slope RT (%)	N/A
			N/A	Flare Traversable LT?	N/A	N/A	Flare Traversable RT?	N/A
			N/A	Landing Length (in)	N/A	N/A	DWS Provided?	N/A
	Surveyor Notes:	N/A	N/A	Landing Width (in)	N/A	N/A	DWS Contrast?	N/A
			N/A	Landing Slope (%)	N/A	N/A	DWS Length (in)	N/A
			N/A	Landing X Slope (%)	N/A	N/A	DWS Full Width?	N/A
			N/A	Landing Curb? (Y/N)	N/A	N/A	DWS Offset (in)	N/A
			N/A	Shared Landing?	N/A			
			N/A	Gutter Ponding?	N/A	N/A	Gutter Slope (%)	N/A
			N/A	Gutter Lip Ht (in)	N/A	N/A	Gutter X Slope (%)	N/A
			N/A	Painted X Walk1?	No	N/A	Painted X Walk2?	N/A
