# Access Compliance Report

## Public Rights-of-Way

### (Curb Ramps)

Intersection ID: 24485	Main Street: CAMAROSS_DR	Cross Street: SAINTFIELD_PL	Location: NE
ADA ID: 1FC8746BC1E6	Ramp Type: Perp	Initial Pass/Fail: Fail	Overall Compliance: No
			Severity Score: 13.75

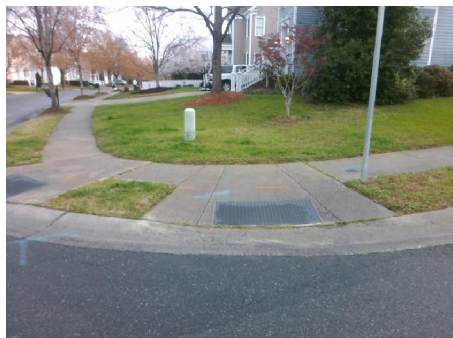
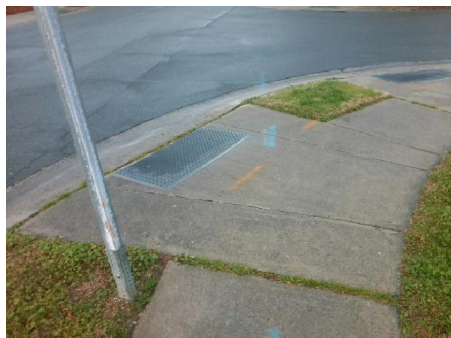
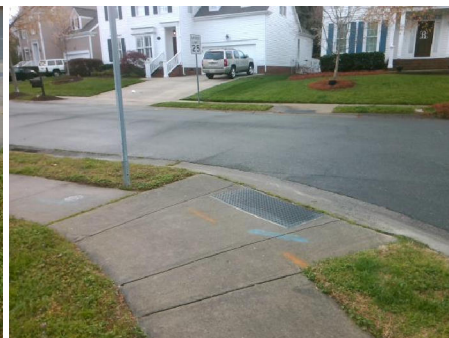
Compliance	Description	Data	Compliance	Description	Data
N/A	Ramp Length (in)	44.0	No	Ramp Slope (%)	8.4
Yes	Ramp Width (in)	48.0	No	Ramp XSlope (%)	3.1
N/A	Flare Type LT	N/A	N/A	Flare Type RT	N/A
N/A	Flare Slope LT (%)	N/A	N/A	Flare Slope RT (%)	N/A
N/A	Flare Traversable LT?	N/A	N/A	Flare Traversable RT?	N/A
N/A	Landing Length (in)	N/A	N/A	DWS Provided?	N/A
N/A	Landing Width (in)	N/A	N/A	DWS Contrast?	N/A
N/A	Landing Slope (%)	N/A	N/A	DWS Length (in)	N/A
N/A	Landing X Slope (%)	N/A	N/A	DWS Full Width?	N/A
N/A	Landing Curb? (Y/N)	N/A	N/A	DWS Offset (in)	N/A
N/A	Shared Landing?	N/A			
N/A	Gutter Ponding?	N/A	N/A	Gutter Slope (%)	N/A
N/A	Gutter Lip Ht (in)	N/A	N/A	Gutter X Slope (%)	N/A
N/A	Painted X Walk1?	No	N/A	Painted X Walk2?	N/A
	X Walk 1 Direction	To S		X Walk 2 Direction	N/A
N/A	X Walk 1 Width (in)	N/A	N/A	X Walk 2 Width (in)	N/A
	X Walk 1 Slope (%)	6.5		X Walk 2 Slope (%)	N/A
	X Walk 1 X Slope (%)	0.1		X Walk 2 X Slope (%)	N/A

N/A	Ramp inside XWalk1?	N/A	N/A	Ramp inside XWalk2?	N/A
	Road Slope (%)	N/A	N/A	Clear Space?	N/A
	Road X Slope (%)	N/A	N/A	Clear Space to XWalk (in)	N/A
N/A	Any Obstructions?	N/A	N/A	Storm Grate/Utility Hazard?	N/A
	Obstruction Type			Storm Grate/Utility Type	
		N/A			N/A
			Yes	Surface Condition? (G/P)	Good

Possible Solutions:				
	Remove & Replace Entire Ramp.				
	Surveyor Notes:				
	N/A				
	PROW/ADA:				
	R304.2.2, R304.5.3				
Street 1 Name	SAINTFIELD PL				
Stop Condition-Street 2	None				
Street 2 Name	N/A				
Stop Condition-Street 1	N/A				
Total Cost:		\$	1850.00
