# Access Compliance Report

## Public Rights-of-Way

### (Curb Ramps)

| Intersection ID: 53253 | Main Street: MARLOWE_AV | Cross Street: ALYSSA_LN | Location: SE |

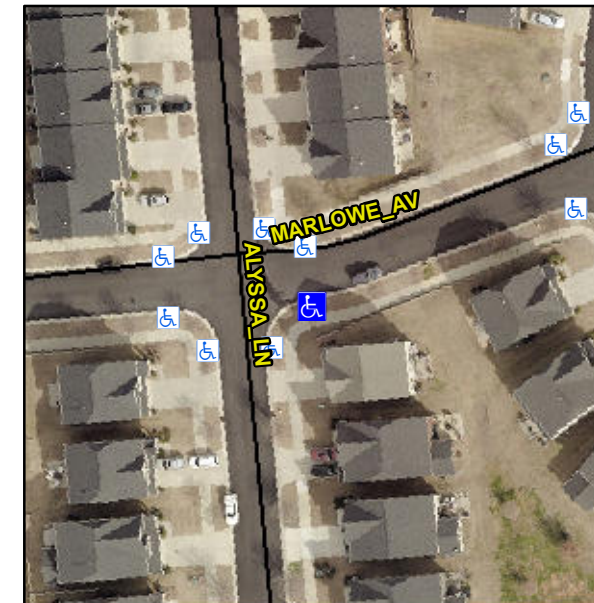
| ADA ID: 1FCC0DCBF860 | Ramp Type: Perp | Initial Pass/Fail: Fail | Overall Compliance: No |
| | | Severity Score: 10 | |

**Not Found, R304.5.1, R304.5.3**

| Compliance | Description | Data | Compliance | Description | Data |
|---|---|---|---|---|---|
| N/A | Ramp Length (in) | 95.0 | Yes | Ramp Slope (%) | 7.3 |
| No | Ramp Width (in) | 47.0 | No | Ramp XSlope (%) | 2.8 |

**Remove & Replace Entire Ramp.**

Total Cost: \$ 1850.00
