Access Compliance Report Public Rights-of-Way (Curb Ramps)

Intersection ID: 19678	Main St	Cross Street: OLDE_WHITEHALL_RD					Location:	SW		
ADA ID: 1FD1A8D7CFD	9 Ramp T	Initial Pass/Fail: Fail Overall Compliance: No				o Severity Score:	12.5			
Codes/Mitigation Info/Possible Solution				Field Measurements/Component Compliance

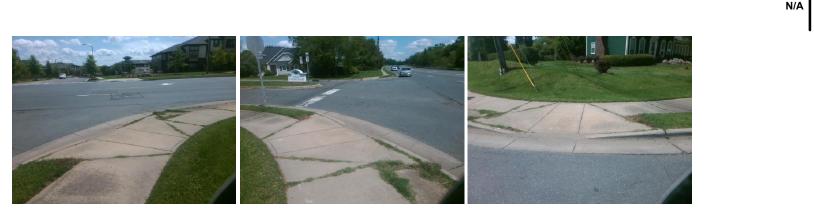
E. E	Possible Solutions:	<u>(</u>	Compliance Description			Data Compliance Description			
		Remove & Replace Curb Ramp W	/ith ¹	N/A	Ramp Length (in)	84.0	No	Ramp Slope (%)	10.1	
		Two New Directional Ramps or		/es	Ramp Width (in)	48.0	Yes	Ramp XSlope (%)	0.1	
		Equivalent.	1	I/A	Flare Type LT	N/A	N/A	Flare Type RT	N/A	
				N/A	Flare Slope LT (%)	N/A	N/A	Flare Slope RT (%)	N/A	
OLDE WHITEHALL R			,	N/A	Flare Traversable LT?	N/A	N/A	Flare Traversable RT?	N/A	
COMPARALL RI				N/A	Landing Length (in)	N/A	N/A	DWS Provided?	N/A	
A TRACK		Surveyor Notes:		N/A	Landing Width (in)	N/A	N/A	DWS Contrast?	N/A	
		N/A		N/A	Landing Slope (%)	N/A	N/A	DWS Length (in)	N/A	
the states		N/A		N/A	Landing X Slope (%)	N/A	N/A	DWS Full Width?	N/A	
		4		N/A	Landing Curb? (Y/N)	N/A	N/A	DWS Offset (in)	N/A	
STATISTICS IN THE				N/A	Shared Landing?	N/A		Dwe enset (iii)	10/0	
and the is a		PROW/ADA:		N/A	Gutter Ponding?	N/A	N/A	Gutter Slope (%)	N/A
