# Access Compliance Report

## Public Rights-of-Way

### (Curb Ramps)

| Intersection ID: 48867 | Main Street: ERWIN_RD | Cross Street: LION_CUB_LN | Location: SE |

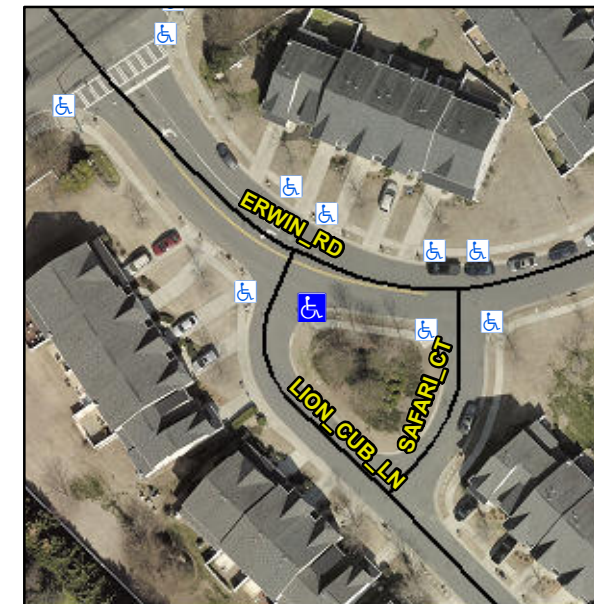
**Not Found, R304.2.1, R304.5.4, R304.5.3**

| Compliance | Description | Data | Compliance | Description | Data |
|---|---|---|---|---|---|
| No | Landing Length (in) | 40.0 | Yes | DWS Provided? | Yes |
| Yes | Gutter Ponding? | No | No | Gutter Slope (%) | 13.3 |
| Yes | Gutter Lip Ht (in) | 0.25 | No | Gutter X Slope (%) | 4.2 |
| | | | No | Curb Slope (%) | 14.3 |

**Remove & Replace Curb Ramp With Two New Directional Ramps or Equivalent. Remove & Replace Gutter.**
