# Access Compliance Report

## Public Rights-of-Way

### (Curb Ramps)

Intersection ID: 14946	Main Street: DILWORTH_RD_WEST	Cross Street: E WORTHINGTON AV	Location:	E
ADA ID: 1FE67368DD6A	Ramp Type: Perp	Initial Pass/Fail: Fail	Overall Compliance: No	Severity Score: 1.25
Codes/Mitigation Info/Possible Solution		Field Measurements/Component Compliance

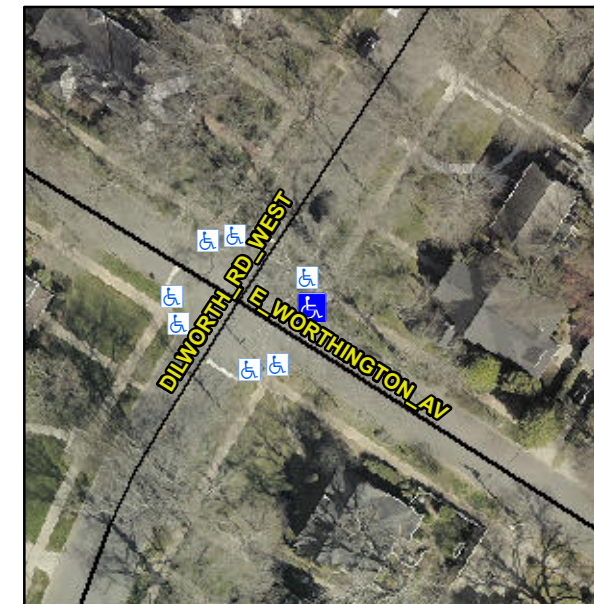
**Not Found, R304.5.3**

Compliance	Description	Data	Compliance	Description	Data
N/A	Ramp Length (in)	48.0	Yes	Ramp Slope (%)	8.3
Yes	Ramp Width (in)	48.0	No	Ramp XSlope (%)	3.7
N/A	Flare Type LT	N/A	N/A	Flare Type RT	N/A
N/A	Flare Slope LT (%)	N/A	N/A	Flare Slope RT (%)	N/A
N/A	Flare Traversable LT?	N/A	N/A	Flare Traversable RT?	N/A
N/A	Landing Length (in)	N/A	N/A	DWS Provided?	N/A
N/A	Landing Width (in)	N/A	N/A	DWS Contrast?	N/A
N/A	Landing Slope (%)	N/A	N/A	DWS Length (in)	N/A
N/A	Landing X Slope (%)	N/A	N/A	DWS Full Width?	N/A
N/A	Landing Curb? (Y/N)	N/A	N/A	DWS Offset (in)	N/A
N/A	Shared Landing?	N/A			
N/A	Gutter Ponding?	N/A	N/A	Gutter Slope (%)	N/A
N/A	Gutter Lip Ht (in)	1.0	N/A	Gutter X Slope (%)	N/A
N/A	Painted X Walk1?	No	N/A	Painted X Walk2?	N/A
	X Walk 1 Direction	To SW		X Walk 2 Direction	N/A
N/A	X Walk 1 Width (in)	N/A	N/A	X Walk 2 Width (in)	N/A
	X Walk 1 Slope (%)	3.2		X Walk 2 Slope (%)	N/A
	X Walk 1 X Slope (%)	0.8		X Walk 2 X Slope (%)	N/A

N/A	Ramp inside XWalk1?	N/A	N/A	Ramp inside XWalk2?	N/A
	Road Slope (%)	N/A	N/A	Clear Space?	N/A
	Road X Slope (%)	N/A	N/A	Clear Space to XWalk (in)	N/A
N/A	Any Obstructions?	N/A	N/A	Storm Grate/Utility Hazard?	N/A
	Obstruction Type			Storm Grate/Utility Type	
		N/A			N/A
			Yes	Surface Condition? (G/P)	Good

**Remove & Replace Entire Ramp.**

Total Cost: \$ 1850.00
