Access Compliance Report

Public Rights-of-Way

(Curb Ramps)

Intersection ID: N/A	Main Street: INVERNESS_BAY_RD	Cross Street: ELGIN_MOOR_RD	Location: NW
ADA ID: 1FEB2786C4C3	Ramp Type: Perp	Initial Pass/Fail: Fail	Overall Compliance: No
		Severity Score: 22.5

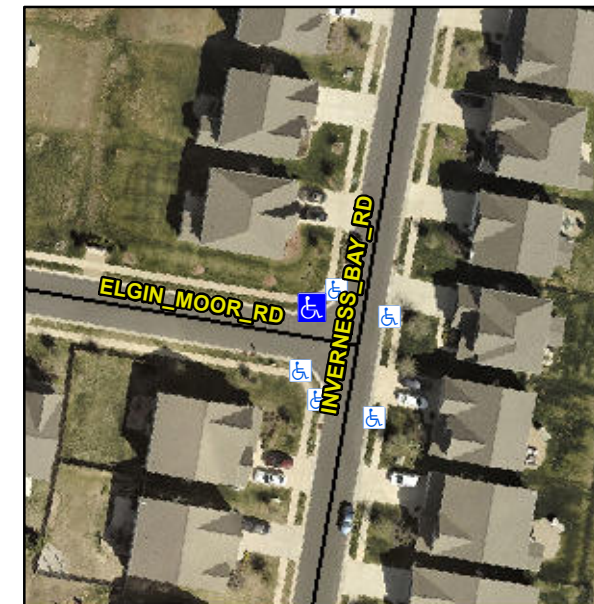
R304.5.1, R304.2.2, R304.5.3

Compliance	Description	Data	Compliance	Description	Data
N/A	Ramp Length (in)	49.0	No	Ramp Slope (%)	10.7
No	Ramp Width (in)	47.0	No	Ramp XSlope (%)	3.0
N/A	Flare Type LT	N/A	N/A	Flare Type RT	N/A
N/A	Flare Slope LT (%)	N/A	N/A	Flare Slope RT (%)	N/A
N/A	Flare Traversable LT?	N/A	N/A	Flare Traversable RT?	N/A
N/A	Landing Length (in)	N/A	N/A	DWS Provided?	N/A
N/A	Landing Width (in)	N/A	N/A	DWS Contrast?	N/A
N/A	Landing Slope (%)	N/A	N/A	DWS Length (in)	N/A
N/A	Landing X Slope (%)	N/A	N/A	DWS Full Width?	N/A
N/A	Landing Curb? (Y/N)	N/A	N/A	DWS Offset (in)	N/A
N/A	Shared Landing?	N/A			
N/A	Gutter Ponding?	N/A	N/A	Gutter Slope (%)	N/A
N/A	Gutter Lip Ht (in)	N/A	N/A	Gutter X Slope (%)	N/A
N/A	Painted X Walk1?	No	N/A	Painted X Walk2?	N/A
	X Walk 1 Direction	To SW		X Walk 2 Direction	N/A
N/A	X Walk 1 Width (in)	N/A	N/A	X Walk 2 Width (in)	N/A
	X Walk 1 Slope (%)	3.1		X Walk 2 Slope (%)	N/A
	X Walk 1 X Slope (%)	1.2		X Walk 2 X Slope (%)	N/A

Possible Solutions:

Remove & Replace Entire Ramp.
