Access Compliance Report

Public Rights-of-Way

(Curb Ramps)

Intersection ID: N/A	Main Street: AGNEW_DR	Cross Street: COWGILL_LN	Location: SE
ADA ID: 1FF0629CEF72	Ramp Type: Perp	Initial Pass/Fail: Fail	Overall Compliance: No
Codes/Mitigation Info/Possible Solution		Field Measurements/Component Compliance	
Severity Score: 21.25

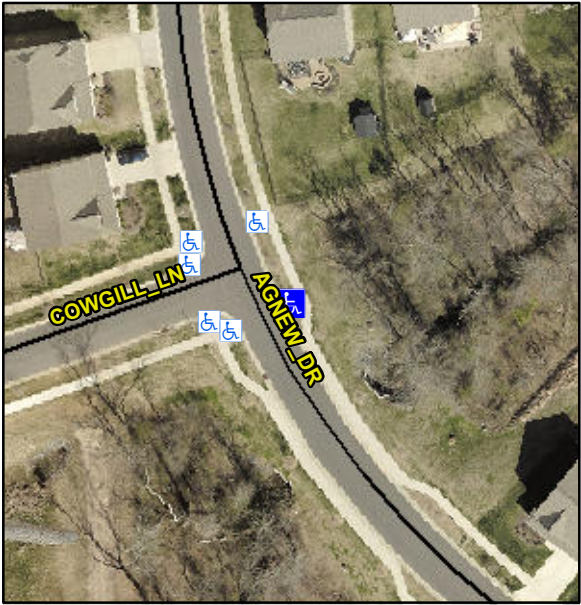
Possible Solutions:						
	Remove & Replace Entire Ramp.						
	Surveyor Notes:						
	N/A						
	PROW/ADA:						
	Not Found, R304.5.1, R304.2.2						
				Compliance	Description	Data	Compliance
				Description			Description
				Data			Data
Street 1 Name	AGNEW DR				N/A	Ramp Length (in)	97.0
Stop Condition-Street 2	None				No	Ramp Width (in)	47.5
Street 2 Name	N/A				N/A	Flare Type LT	N/A
Stop Condition-Street 1	N/A				N/A	Flare Slope LT (%)	N/A
				N/A	Flare Traversable LT?	N/A	N/A
				N/A	Flare Slope RT (%)	N/A	N/A
				N/A	Flare Traversable RT?	N/A	N/A
				N/A	DWS Provided?	N/A	N/A
				N/A	DWS Contrast?	N/A	N/A
				N/A	DWS Length (in)	N/A	N/A
				N/A	DWS Full Width?	N/A	N/A
				N/A	DWS Offset (in)	N/A	N/A
				N/A	Shared Landing?	N/A	
				N/A	Gutter Ponding?	N/A	N/A
				N/A	Gutter Lip Ht (in)	N/A	N/A
				N/A	Painted X Walk1?	No	N/A
					X Walk 1 Direction	To SW	X Walk 2 Direction
				N/A	X Walk 1 Width (in)	N/A	N/A

X Walk 1 Slope (%)	3.5	X Walk 2 Width (in)
					X Walk 1 X Slope (%)	1.4	X Walk 2 Slope (%)
				N/A	Ramp inside XWalk1?	N/A	N/A
					Ramp inside XWalk2?	N/A	N/A
					Road Slope (%)	N/A	N/A
					Clear Space?	N/A	N/A
					Clear Space to XWalk (in)	N/A	N/A
				N/A	Any Obstructions?	N/A	N/A
					Obstruction Type		Storm Grate/Utility Hazard?
							Storm Grate/Utility Type
				N/A			N/A
				Yes	Surface Condition? (G/P)		Good
