Intersection ID: 16716	Main Street: BUCKNELL_AV	Cross Street: HASTINGS_DR	Location:	NE
ADA ID: 200E2EB22226	Ramp Type: PerpDiag	Initial Pass/Fail: Fail	Overall Compliance: No	Severity Score: 13.75

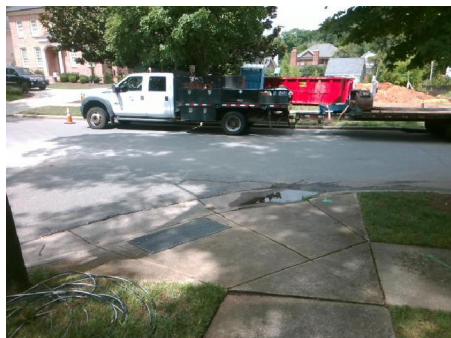
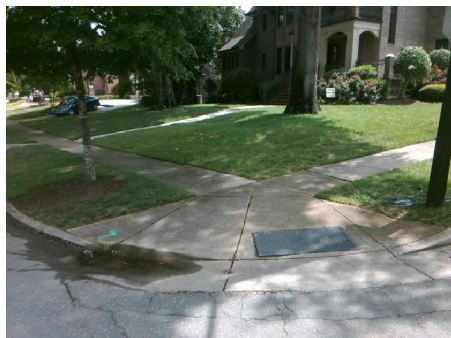
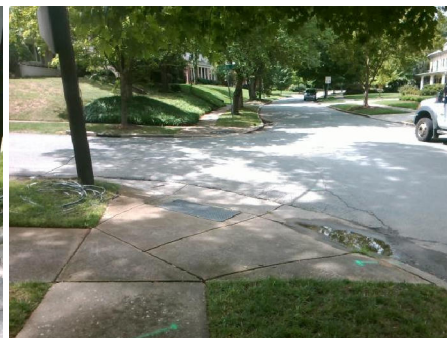
**Not Found, R304.2.2, R304.5.3**

Compliance	Description	Data	Compliance	Description	Data
N/A	Ramp Length (in)	81.0	No	Ramp Slope (%)	10.1
Yes	Ramp Width (in)	78.0	No	Ramp XSlope (%)	4.8
N/A	Flare Type LT	N/A	N/A	Flare Type RT	N/A
N/A	Flare Slope LT (%)	N/A	N/A	Flare Slope RT (%)	N/A
N/A	Flare Traversable LT?	N/A	N/A	Flare Traversable RT?	N/A
N/A	Landing Length (in)	N/A	N/A	DWS Provided?	N/A
N/A	Landing Width (in)	N/A	N/A	DWS Contrast?	N/A
N/A	Landing Slope (%)	N/A	N/A	DWS Length (in)	N/A
N/A	Landing X Slope (%)	N/A	N/A	DWS Full Width?	N/A
N/A	Landing Curb? (Y/N)	N/A	N/A	DWS Offset (in)	N/A
N/A	Shared Landing?	N/A			
N/A	Gutter Ponding?	N/A	N/A	Gutter Slope (%)	N/A
N/A	Gutter Lip Ht (in)	N/A	N/A	Gutter X Slope (%)	N/A
N/A	Painted X Walk1?	No	N/A	Painted X Walk2?	No
	X Walk 1 Direction	To NW		X Walk 2 Direction	To SW
N/A	X Walk 1 Width (in)	N/A	N/A	X Walk 2 Width (in)	N/A
	X Walk 1 Slope (%)	2.4		X Walk 2 Slope (%)	2.9
	X Walk 1 X Slope (%)	2.9		X Walk 2 X Slope (%)	4.5

N/A	Ramp inside XWalk1?	N/A	N/A	Ramp inside XWalk2?	N/A
	Road Slope (%)	4.3	N/A	Clear Space?	N/A
	Road X Slope (%)	2.3	N/A	Clear Space to XWalk (in)	N/A
N/A	Any Obstructions?	N/A	N/A	Storm Grate/Utility Hazard?	N/A
	Obstruction Type			Storm Grate/Utility Type	
		N/A			N/A
			Yes	Surface Condition? (G/P)	Good

**Remove & Replace Curb Ramp With Two New Directional Ramps or Equivalent.**
