Access Compliance Report Public Rights-of-Way (Curb Ramps)

Intersection ID: 11639Main Street:PARKWOOD_AVCross Street:PEGRAM_STLocation:NEADA ID: 2011B1EE9736Ramp Type:PerpInitial Pass/Fail:FailOverall Compliance:NoSeverity Score:22.5

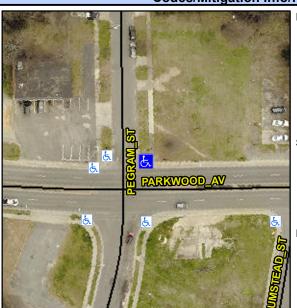
Field Measurements/Component Compliance							
Compl	iance Description	Data	Compl	iance	Description	Data	
N/A	Ramp Length (in)	50.5	No	Ramp	Slope (%)	8.5	
No	Ramp Width (in)	46.5	No	Ramp	XSlope (%)	3.1	
N/A	Flare Type LT	N/A	N/A	Flare	Type RT	N/A	
N/A	Flare Slope LT (%)	N/A	N/A	Flare	Slope RT (%)	N/A	
N/A	Flare Traversable LT?	N/A	N/A	Flare	Traversable RT?	N/A	
N/A	Landing Length (in)	N/A	N/A	DWS	Provided?	N/A	
N/A	Landing Width (in)	N/A	N/A	DWS	Contrast?	N/A	
N/A	Landing Slope (%)	N/A	N/A	DWS	Length (in)	N/A	
N/A	Landing X Slope (%)	N/A	N/A	DWS	Full Width?	N/A	
N/A	Landing Curb? (Y/N)	N/A	N/A	DWS	Offset (in)	N/A	
N/A	Shared Landing?	N/A					
N/A	Gutter Ponding?	N/A	N/A	Gutte	r Slope (%)	N/A	
N/A	Gutter Lip Ht (in)	N/A	N/A	Gutte	r X Slope (%)	N/A	
N/A	Painted X Walk1?	No	N/A	Paint	ed X Walk2?	N/A	
	X Walk 1 Direction	To SE		X Wa	lk 2 Direction	N/A	
N/A	X Walk 1 Width (in)	N/A	N/A	X Wa	lk 2 Width (in)	N/A

X Walk 1 Slope (%)	1.0		X Wa	lk 2 Slope (%)	N/A	
	X Walk 1 X Slope (%)	2.9		X Wa	lk 2 X Slope (%)	N/A	
N/A	Ramp inside XWalk1?	N/A	N/A	Ramp	inside XWalk2?	N/A	
	Road Slope (%)	N/A	N/A	Clear	Space?	N/A	
	Road X Slope (%)	N/A	N/A	Clear	Space to XWalk (in)	N/A	
N/A	Any Obstructions?	N/A	N/A	Storm	n Grate/Utility Hazard?	N/A	
	Obstruction Type			Storm	Grate/Utility Type		
		N/A				N/A	
			Yes	Surfa	ce Condition? (G/P)	Good

2000	Possible Solutions:	Compl
ALC: U	Remove & Replace Entire Ramp.	N/A
		No
1000		N/A
100		N/A
		N/A
9		N/A
100	Surveyor Notes:	N/A
	N/A	N/A
		N/A
1800		N/A
i		N/A
	PROW/ADA:	N/A
	Not Found, R304.5.1, R304.2.2,	N/A
1	R304.5.3	N/A
1		N/A
		N/A
