Access Compliance Report

Public Rights-of-Way

(Curb Ramps)

Intersection ID: 8529	Main Street: LASALLE_ST	Cross Street: BROWNSTONE_ST	Location: NW
ADA ID: 2011B76A8DE6	Ramp Type: Perp	Initial Pass/Fail: Fail	Overall Compliance: No
Codes/Mitigation Info/Possible Solution		Field Measurements/Component Compliance	
Severity Score: 18.75

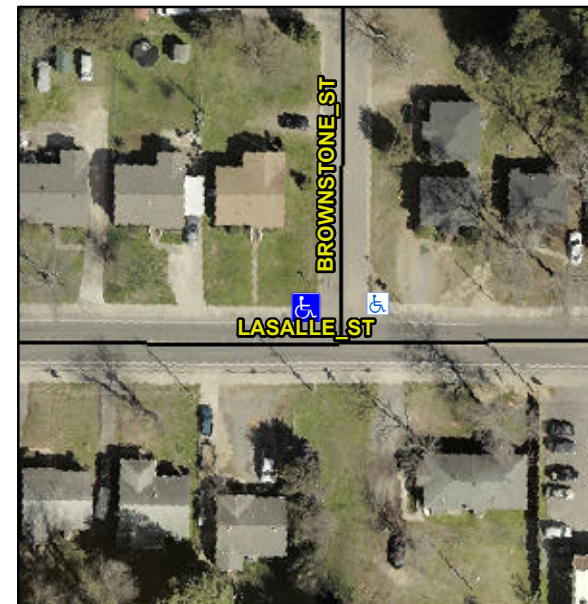
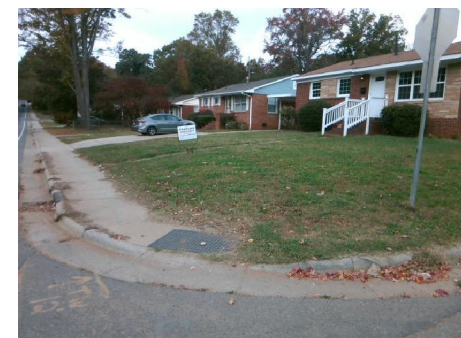
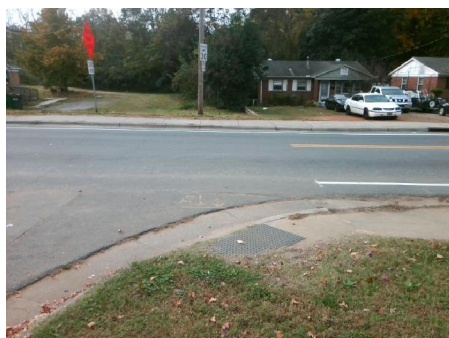
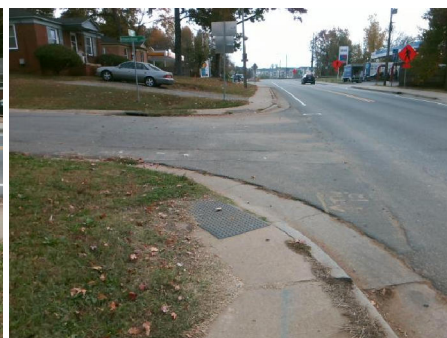
Not Found, R304.5.1, R304.5.3

Compliance	Description	Data	Compliance	Description	Data
N/A	Ramp Length (in)	51.0	Yes	Ramp Slope (%)	6.2
No	Ramp Width (in)	33.0	No	Ramp XSlope (%)	3.5
N/A	Flare Type LT	N/A	N/A	Flare Type RT	N/A
N/A	Flare Slope LT (%)	N/A	N/A	Flare Slope RT (%)	N/A
N/A	Flare Traversable LT?	N/A	N/A	Flare Traversable RT?	N/A
N/A	Landing Length (in)	N/A	N/A	DWS Provided?	N/A
N/A	Landing Width (in)	N/A	N/A	DWS Contrast?	N/A
N/A	Landing Slope (%)	N/A	N/A	DWS Length (in)	N/A
N/A	Landing X Slope (%)	N/A	N/A	DWS Full Width?	N/A
N/A	Landing Curb? (Y/N)	N/A	N/A	DWS Offset (in)	N/A
N/A	Shared Landing?	N/A			
N/A	Gutter Ponding?	N/A	N/A	Gutter Slope (%)	N/A
N/A	Gutter Lip Ht (in)	1.0	N/A	Gutter X Slope (%)	N/A
N/A	Painted X Walk1?	No	N/A	Painted X Walk2?	N/A
	X Walk 1 Direction	To E		X Walk 2 Direction	N/A
N/A	X Walk 1 Width (in)	N/A	N/A	X Walk 2 Width (in)	N/A
	X Walk 1 Slope (%)	0.2		X Walk 2 Slope (%)	N/A
	X Walk 1 X Slope (%)	1.8		X Walk 2 X Slope (%)	N/A

N/A	Ramp inside XWalk1?	N/A	N/A	Ramp inside XWalk2?	N/A
	Road Slope (%)	N/A	N/A	Clear Space?	N/A
	Road X Slope (%)	N/A	N/A	Clear Space to XWalk (in)	N/A
N/A	Any Obstructions?	N/A	N/A	Storm Grate/Utility Hazard?	N/A
	Obstruction Type			Storm Grate/Utility Type	
		N/A			N/A
			Yes	Surface Condition? (G/P)	Good

Remove & Replace Entire Ramp.
