| Intersection ID: 49893 | Main Street: ROCKY_FORD_CLUB_RD | Cross Street: RIDGEVIEW_COMMONS_DR | Location: | N |
| ADA ID: 20201E9F53D7 | Ramp Type: PerpDiag | Initial Pass/Fail: Fail | Overall Compliance: No | Severity Score: 10 |

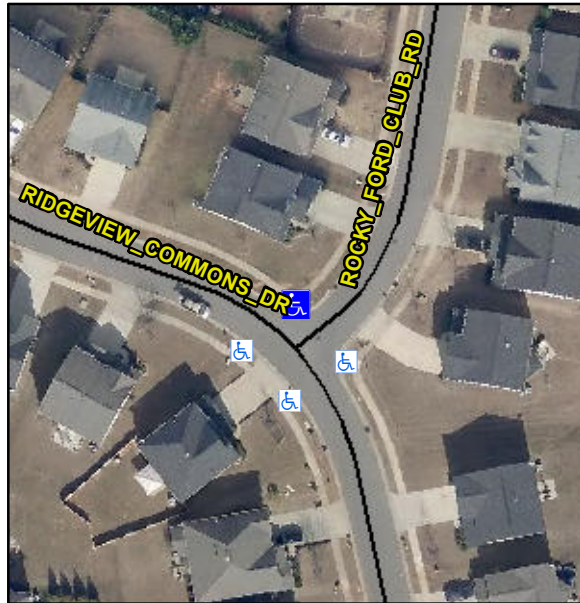
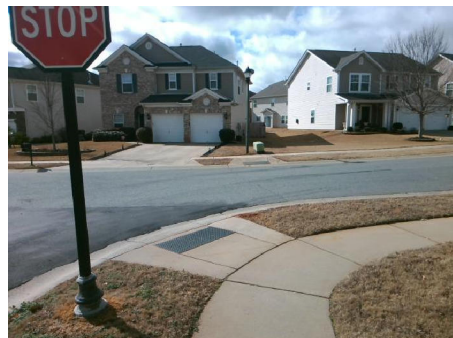
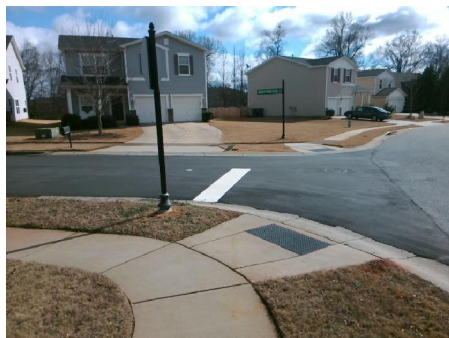
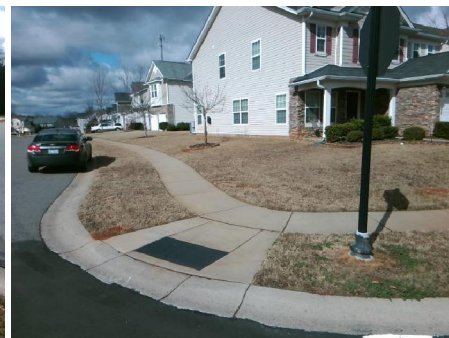
**Not Found, R304.5.1, R304.5.3**

| Compliance | Description | Data | Compliance | Description | Data |
|---|---|---|---|---|---|
| N/A | Ramp Length (in) | 70.0 | Yes | Ramp Slope (%) | 5.9 |
| No | Ramp Width (in) | 39.0 | No | Ramp XSlope (%) | 3.7 |

**Remove & Replace Curb Ramp With Two New Directional Ramps or Equivalent.**
