Access Compliance Report

Public Rights-of-Way

(Curb Ramps)

Intersection ID: 44731	Main Street: BENFIELD_RD	Cross Street: PROSPERITY_PARK_DR	Location:	N
ADA ID: 2024F44BA64D	Ramp Type: PerpDiag	Initial Pass/Fail: Fail	Overall Compliance: No	Severity Score: 25
Codes/Mitigation Info/Possible Solution		Field Measurements/Component Compliance

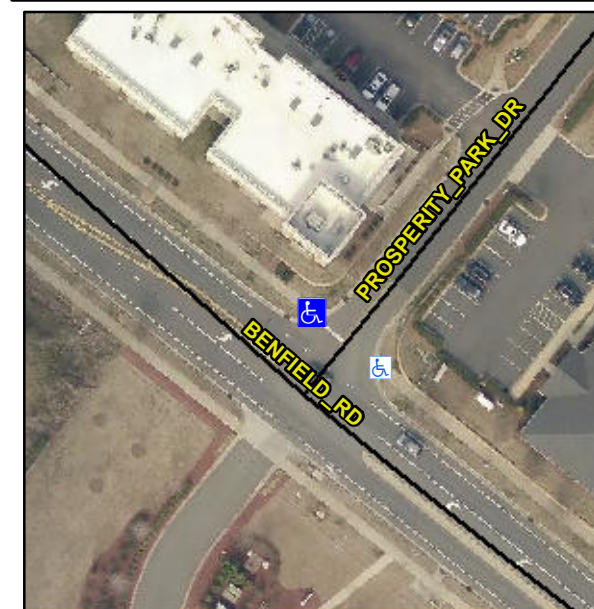
Compliance	Description	Data	Compliance	Description	Data
N/A	Ramp Length (in)	71.0	No	Ramp Slope (%)	20.0
Yes	Ramp Width (in)	49.0	Yes	Ramp XSlope (%)	0.0
N/A	Flare Type LT	N/A	N/A	Flare Type RT	N/A
N/A	Flare Slope LT (%)	N/A	N/A	Flare Slope RT (%)	N/A
N/A	Flare Traversable LT?	N/A	N/A	Flare Traversable RT?	N/A
N/A	Landing Length (in)	N/A	N/A	DWS Provided?	N/A
N/A	Landing Width (in)	N/A	N/A	DWS Contrast?	N/A
N/A	Landing Slope (%)	N/A	N/A	DWS Length (in)	N/A
N/A	Landing X Slope (%)	N/A	N/A	DWS Full Width?	N/A
N/A	Landing Curb? (Y/N)	N/A	N/A	DWS Offset (in)	N/A
N/A	Shared Landing?	N/A			
N/A	Gutter Ponding?	N/A	N/A	Gutter Slope (%)	N/A
N/A	Gutter Lip Ht (in)	N/A	N/A	Gutter X Slope (%)	N/A
N/A	Painted X Walk1?	No	N/A	Painted X Walk2?	No
	X Walk 1 Direction	To SW		X Walk 2 Direction	To SE
N/A	X Walk 1 Width (in)	N/A	N/A	X Walk 2 Width (in)	N/A
	X Walk 1 Slope (%)	0.9		X Walk 2 Slope (%)	2.3
	X Walk 1 X Slope (%)	1.6		X Walk 2 X Slope (%)	2.1

N/A	Ramp inside XWalk1?	N/A	N/A	Ramp inside XWalk2?	N/A
	Road Slope (%)	1.7	N/A	Clear Space?	N/A
	Road X Slope (%)	1.2	N/A	Clear Space to XWalk (in)	N/A
N/A	Any Obstructions?	N/A	N/A	Storm Grate/Utility Hazard?	N/A
	Obstruction Type			Storm Grate/Utility Type	
		N/A			N/A
			Yes	Surface Condition? (G/P)	Good

Possible Solutions:

Remove & Replace Curb Ramp With Two New Directional Ramps or Equivalent.
