Access Compliance Report

Public Rights-of-Way

(Curb Ramps)

Intersection ID: 16122	Main Street: BEVERLY_DR	Cross Street: OXFORD_PL	Location: SW
ADA ID: 2037371B5AFE	Ramp Type: PerpDiag	Initial Pass/Fail: Fail	Overall Compliance: No
			Severity Score: 13.75

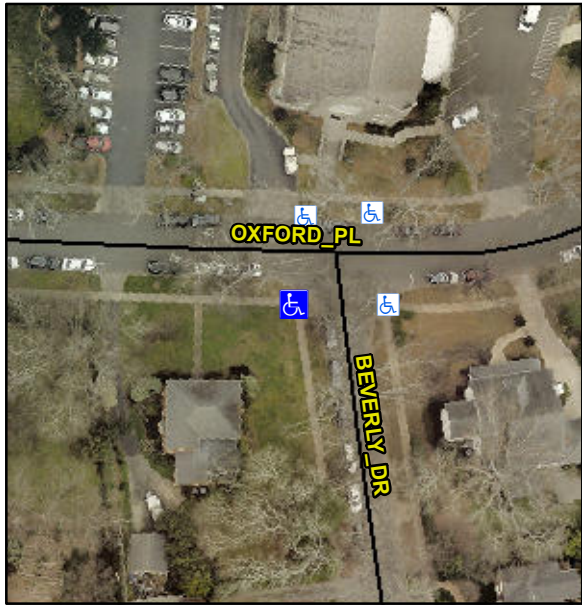
Possible Solutions:		Compliance	Description	Data	Compliance	Description	Data
	Remove & Replace Curb Ramp With Two New Directional Ramps or Equivalent.		N/A	Ramp Length (in)	58.0	No	Ramp Slope (%)	9.9
			Yes	Ramp Width (in)	48.0	No	Ramp XSlope (%)	3.2
			N/A	Flare Type LT	N/A	N/A	Flare Type RT	N/A
			N/A	Flare Slope LT (%)	N/A	N/A	Flare Slope RT (%)	N/A
			N/A	Flare Traversable LT?	N/A	N/A	Flare Traversable RT?	N/A
			N/A	Landing Length (in)	N/A	N/A	DWS Provided?	N/A
			N/A	Landing Width (in)	N/A	N/A	DWS Contrast?	N/A
			N/A	Landing Slope (%)	N/A	N/A	DWS Length (in)	N/A
			N/A	Landing X Slope (%)	N/A	N/A	DWS Full Width?	N/A
Surveyor Notes:	N/A		N/A	Landing Curb? (Y/N)	N/A	N/A	DWS Offset (in)	N/A
			N/A	Shared Landing?	N/A			
	PROW/ADA:		N/A	Gutter Ponding?	N/A	N/A	Gutter Slope (%)	N/A
	Not Found, R304.2.2, R304.5.3		N/A	Gutter Lip Ht (in)	N/A	N/A	Gutter X Slope (%)	N/A

N/A	Painted X Walk1?	No	N/A	Painted X Walk2?	No
				X Walk 1 Direction	To SE		X Walk 2 Direction	To N
			N/A	X Walk 1 Width (in)	N/A	N/A	X Walk 2 Width (in)	N/A
				X Walk 1 Slope (%)	1.7		X Walk 2 Slope (%)	2.6
				X Walk 1 X Slope (%)	0.5		X Walk 2 X Slope (%)	1.9
			N/A	Ramp inside XWalk1?	N/A	N/A	Ramp inside XWalk2?	N/A
			Road Slope (%)	0.4	N/A	Clear Space?	N/A	
			Road X Slope (%)	1.2	N/A	Clear Space to XWalk (in)	N/A	
		N/A	Any Obstructions?	N/A	N/A	Storm Grate/Utility Hazard?	N/A	
			Obstruction Type			Storm Grate/Utility Type		
					N/A		N/A	
					Yes	Surface Condition? (G/P)	Good	
Total Cost:		\$	3200.00
