Access Compliance Report

Public Rights-of-Way

(Curb Ramps)

Intersection ID: 13917	Main Street: MORNINGSIDE_DR	Cross Street: MCCLINTOCK_RD	Location:	N
ADA ID: 203CFD691EFE	Ramp Type: Perp	Initial Pass/Fail: Fail	Overall Compliance: No	Severity Score: 13.75
Codes/Mitigation Info/Possible Solution		Field Measurements/Component Compliance

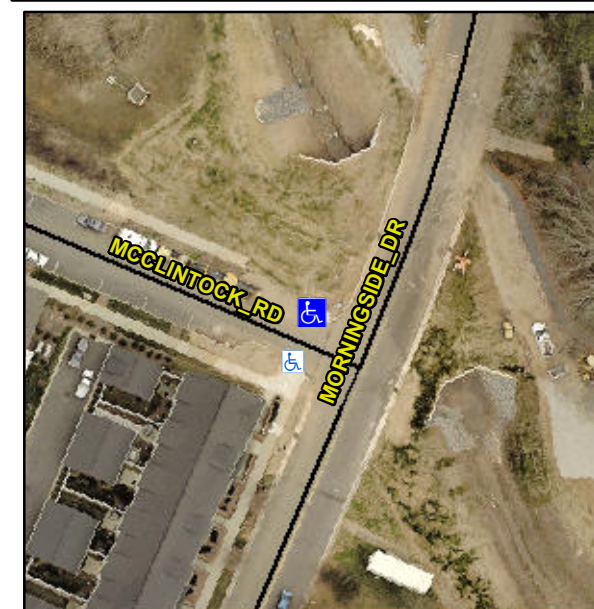
Not Found, R304.2.2, R304.5.3

Compliance	Description	Data	Compliance	Description	Data
N/A	Ramp Length (in)	50.0	No	Ramp Slope (%)	9.3
Yes	Ramp Width (in)	48.0	No	Ramp XSlope (%)	2.6
N/A	Flare Type LT	N/A	N/A	Flare Type RT	N/A
N/A	Flare Slope LT (%)	N/A	N/A	Flare Slope RT (%)	N/A
N/A	Flare Traversable LT?	N/A	N/A	Flare Traversable RT?	N/A
N/A	Landing Length (in)	N/A	N/A	DWS Provided?	N/A
N/A	Landing Width (in)	N/A	N/A	DWS Contrast?	N/A
N/A	Landing Slope (%)	N/A	N/A	DWS Length (in)	N/A
N/A	Landing X Slope (%)	N/A	N/A	DWS Full Width?	N/A
N/A	Landing Curb? (Y/N)	N/A	N/A	DWS Offset (in)	N/A
N/A	Shared Landing?	N/A			
N/A	Gutter Ponding?	N/A	N/A	Gutter Slope (%)	N/A
N/A	Gutter Lip Ht (in)	N/A	N/A	Gutter X Slope (%)	N/A
N/A	Painted X Walk1?	No	N/A	Painted X Walk2?	N/A
	X Walk 1 Direction	To SW		X Walk 2 Direction	N/A
N/A	X Walk 1 Width (in)	N/A	N/A	X Walk 2 Width (in)	N/A
	X Walk 1 Slope (%)	3.9		X Walk 2 Slope (%)	N/A
	X Walk 1 X Slope (%)	5.6		X Walk 2 X Slope (%)	N/A

Possible Solutions:

Remove & Replace Entire Ramp.

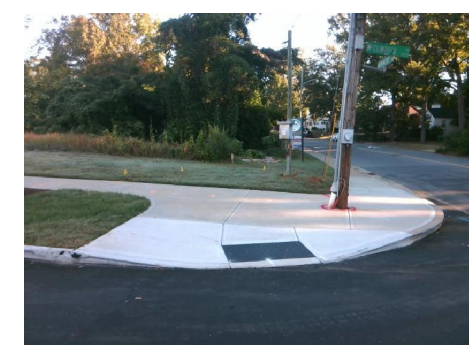
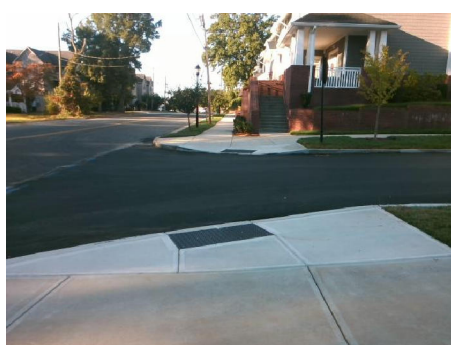
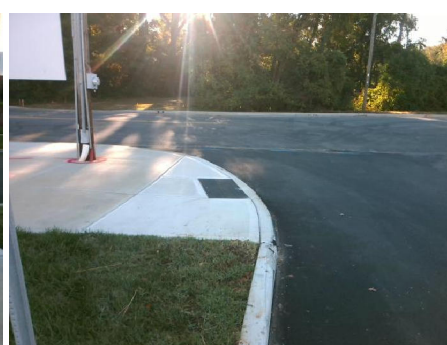
N/A	Ramp inside XWalk1?	N/A	N/A	Ramp inside XWalk2?	N/A
	Road Slope (%)	N/A	N/A	Clear Space?	N/A
	Road X Slope (%)	N/A	N/A	Clear Space to XWalk (in)	N/A
N/A	Any Obstructions?	N/A	N/A	Storm Grate/Utility Hazard?	N/A
	Obstruction Type			Storm Grate/Utility Type	
		N/A			N/A
			Yes	Surface Condition? (G/P)	Good
