# Access Compliance Report

## Public Rights-of-Way

### (Curb Ramps)

Intersection ID: 5058	Main Street: KILLARNEY_PL	Cross Street: MORNING_GLORY_DR	Location: E
ADA ID: 2040C7B13D3D	Ramp Type: Perp	Initial Pass/Fail: Fail	Overall Compliance: No
Codes/Mitigation Info/Possible Solution		Field Measurements/Component Compliance	
Severity Score: 13.75

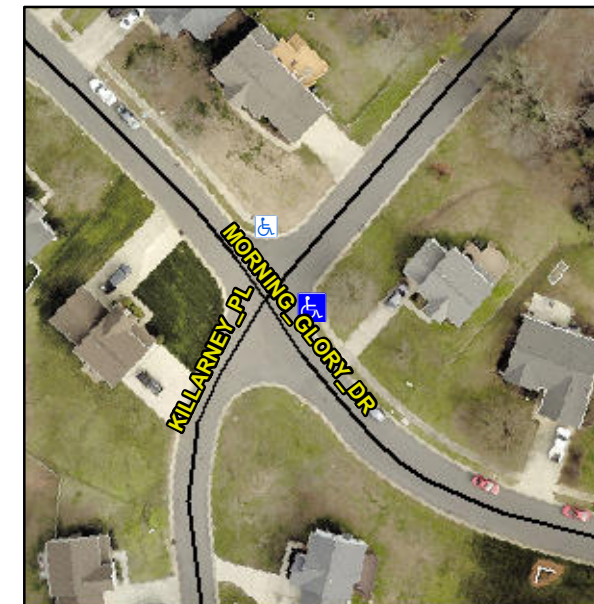
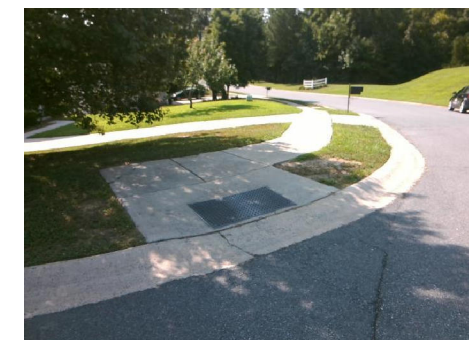
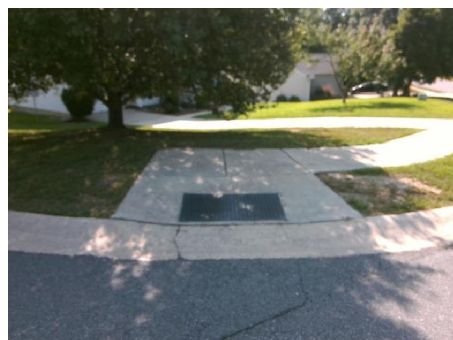
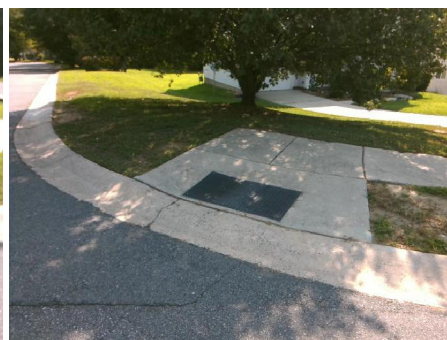
**Not Found, R304.2.2, R304.5.3**

Compliance	Description	Data	Compliance	Description	Data
N/A	Ramp Length (in)	48.0	No	Ramp Slope (%)	10.5
Yes	Ramp Width (in)	48.0	No	Ramp XSlope (%)	4.4
N/A	Flare Type LT	N/A	N/A	Flare Type RT	N/A
N/A	Flare Slope LT (%)	N/A	N/A	Flare Slope RT (%)	N/A
N/A	Flare Traversable LT?	N/A	N/A	Flare Traversable RT?	N/A
N/A	Landing Length (in)	N/A	N/A	DWS Provided?	N/A
N/A	Landing Width (in)	N/A	N/A	DWS Contrast?	N/A
N/A	Landing Slope (%)	N/A	N/A	DWS Length (in)	N/A
N/A	Landing X Slope (%)	N/A	N/A	DWS Full Width?	N/A
N/A	Landing Curb? (Y/N)	N/A	N/A	DWS Offset (in)	N/A
N/A	Shared Landing?	N/A			
N/A	Gutter Ponding?	N/A	N/A	Gutter Slope (%)	N/A
N/A	Gutter Lip Ht (in)	N/A	N/A	Gutter X Slope (%)	N/A
N/A	Painted X Walk1?	No	N/A	Painted X Walk2?	N/A
	X Walk 1 Direction	To NW		X Walk 2 Direction	N/A
N/A	X Walk 1 Width (in)	N/A	N/A	X Walk 2 Width (in)	N/A
	X Walk 1 Slope (%)	4.2		X Walk 2 Slope (%)	N/A
	X Walk 1 X Slope (%)	2.2		X Walk 2 X Slope (%)	N/A

N/A	Ramp inside XWalk1?	N/A	N/A	Ramp inside XWalk2?	N/A
	Road Slope (%)	N/A	N/A	Clear Space?	N/A
	Road X Slope (%)	N/A	N/A	Clear Space to XWalk (in)	N/A
N/A	Any Obstructions?	N/A	N/A	Storm Grate/Utility Hazard?	N/A
	Obstruction Type			Storm Grate/Utility Type	
		N/A			N/A
			Yes	Surface Condition? (G/P)	Good

**Remove & Replace Entire Ramp.**

Total Cost: \$ 1850.00
