# Access Compliance Report

## Public Rights-of-Way

| Intersection ID: 15958 | Main Street: HARRI_ANN_DR | Cross Street: OTTAWA_LN | Location: SE |
| ADA ID: 204BB849DED9 | Ramp Type: BlendTrans2 | Initial Pass/Fail: Fail | Overall Compliance: No |

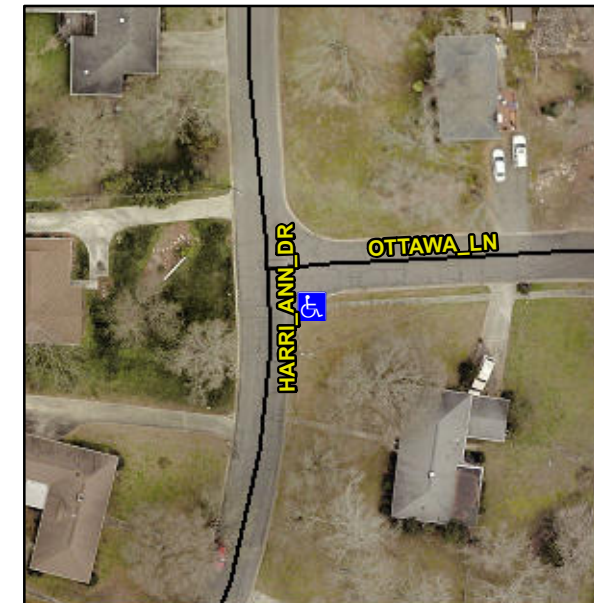
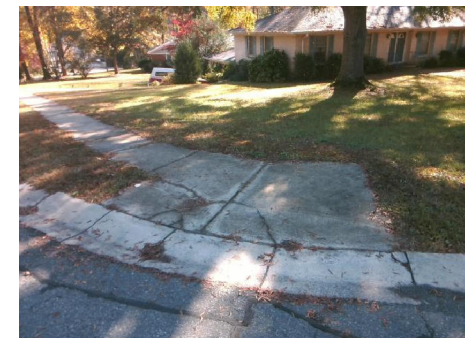
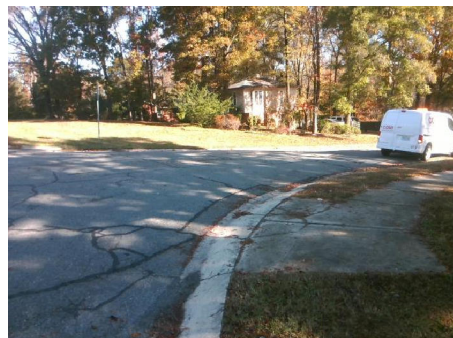
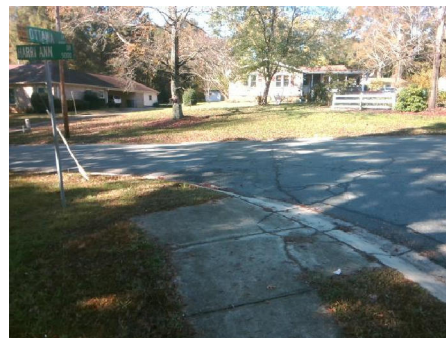
**Not Found, R304.5.1, R304.5.3**

| Compliance | Description | Data | Compliance | Description | Data |
|---|---|---|---|---|---|
| N/A | Ramp Length (in) | 86.0 | Yes | BlendTrans Slope (%) | 1.9 |
| No | Ramp Width (in) | 42.0 | No | BlendTrans XSlope (%) | 2.8 |

**Remove & Replace Curb Ramp With Two New Directional Ramps or Equivalent.**

Total Cost: \$ 3200.00
