# Access Compliance Report

## Public Rights-of-Way

### (Curb Ramps)

Intersection ID: N/A	Main Street: WESTINGHOUSE_BV	Cross Street: CORDAGE_ST	Location: NE
ADA ID: 2060EF6365B9	Ramp Type: PerpDiag	Initial Pass/Fail: Fail	Overall Compliance: No
Codes/Mitigation Info/Possible Solution		Field Measurements/Component Compliance

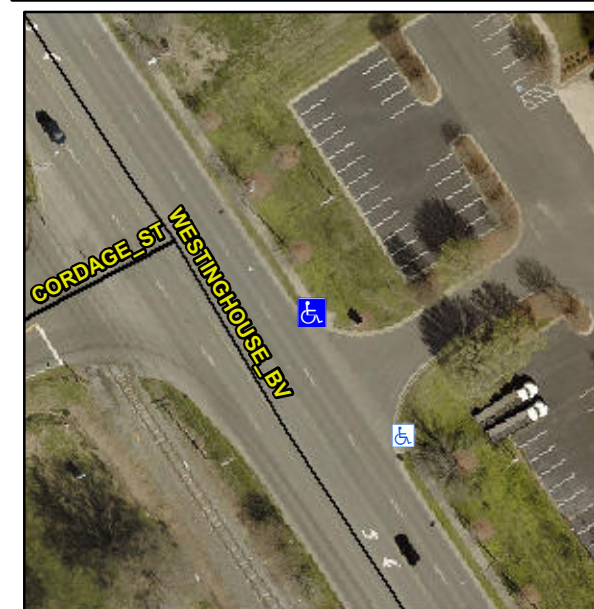
Compliance	Description	Data	Compliance	Description	Data
N/A	Ramp Length (in)	86.0	Yes	Ramp Slope (%)	6.4
No	Ramp Width (in)	43.0	No	Ramp XSlope (%)	3.4
N/A	Flare Type LT	N/A	N/A	Flare Type RT	N/A
N/A	Flare Slope LT (%)	N/A	N/A	Flare Slope RT (%)	N/A
N/A	Flare Traversable LT?	N/A	N/A	Flare Traversable RT?	N/A
N/A	Landing Length (in)	N/A	N/A	DWS Provided?	N/A
N/A	Landing Width (in)	N/A	N/A	DWS Contrast?	N/A
N/A	Landing Slope (%)	N/A	N/A	DWS Length (in)	N/A
N/A	Landing X Slope (%)	N/A	N/A	DWS Full Width?	N/A
N/A	Landing Curb? (Y/N)	N/A	N/A	DWS Offset (in)	N/A
N/A	Shared Landing?	N/A			
N/A	Gutter Ponding?	N/A	N/A	Gutter Slope (%)	N/A
N/A	Gutter Lip Ht (in)	N/A	N/A	Gutter X Slope (%)	N/A
N/A	Painted X Walk1?	No	N/A	Painted X Walk2?	No
	X Walk 1 Direction	To W		X Walk 2 Direction	To S
N/A	X Walk 1 Width (in)	N/A	N/A	X Walk 2 Width (in)	N/A
	X Walk 1 Slope (%)	3.0		X Walk 2 Slope (%)	1.3
	X Walk 1 X Slope (%)	0.3		X Walk 2 X Slope (%)	3.9

N/A	Ramp inside XWalk1?	N/A	N/A	Ramp inside XWalk2?	N/A
	Road Slope (%)	2.3	N/A	Clear Space?	N/A
	Road X Slope (%)	4.0	N/A	Clear Space to XWalk (in)	N/A
N/A	Any Obstructions?	N/A	N/A	Storm Grate/Utility Hazard?	N/A
	Obstruction Type			Storm Grate/Utility Type	
		N/A			N/A
			Yes	Surface Condition? (G/P)	Good

**Remove & Replace Curb Ramp With Two New Directional Ramps or Equivalent.**

**R304.5.1, R304.5.3**
