Access Compliance Report Public Rights-of-Way (Curb Ramps)

Intersection ID: 13598	3598 Main Street: W_KINGSTON_AV			Cross Street: WICKFORD_PL				Location:	NE
ADA ID: 206DBA559CB5	DA ID: 206DBA559CB5 Ramp Type: Perp			Initial Pass/Fail: Fail Overall Compliance: No				o Severity Score:	1.25
Codes/Mitigation Info/Possible Solution				Field Measurements/Component Compliance					
	A State of	Possible Solutions:		Compliance Description			Data Compliance Description		
	" The share	Remove & Replace Entire Ra	mp.	N/A	Ramp Length (in)	56.0	Yes	Ramp Slope (%)	6.6
A . Contax	1 NA		•	Yes	Ramp Width (in)	60.0	No	Ramp XSlope (%)	3.7
Charles The State	ALAR			N/A	Flare Type LT	N/A	N/A	Flare Type RT	N/A
	1			N/A	Flare Slope LT (%)	N/A	N/A	Flare Slope RT (%)	N/A
A ALL	11011			N/A	Flare Traversable LT?	N/A	N/A	Flare Traversable RT?	N/A
				N/A	Landing Length (in)	N/A	N/A	DWS Provided?	N/A
		Surveyor Notes:		N/A	Landing Width (in)	N/A	N/A	DWS Contrast?	N/A
	The Maria	N/A		N/A	Landing Slope (%)	N/A	N/A	DWS Length (in)	N/A

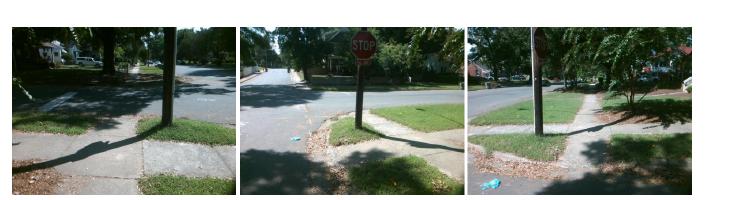
6. A		PROW/ADA:		N/A	Gutter Ponding?	N/A	N/A	Gutter Slope (%)	N/A
Not Found, R304.5.3				N/A	Gutter Lip Ht (in)	N/A	N/A	Gutter X Slope (%)	N/A
				N/A	Painted X Walk1?	No	N/A	Painted X Walk2?	N/A
					X Walk 1 Direction	To SE		X Walk 2 Direction	N/A
				N/A	X Walk 1 Width (in)	N/A	N/A	X Walk 2 Width (in)	N/A
Street 1 Name	WICKFORD PL				X Walk 1 Slope (%)	5.6		X Walk 2 Slope (%)	N/A
Stop Condition-Street 2	StopSign				X Walk 1 X Slope (%)	2.6		X Walk 2 X Slope (%)	N/A
Street 2 Name	N/A			N/A	Ramp inside XWalk1?	N/A	N/A	Ramp inside XWalk2?	N/A
Stop Condition-Street 1	N/A				Road Slope (%)	N/A	N/A	Clear Space?	N/A
					Road X Slope (%)	N/A	N/A	Clear Space to XWalk (in)	N/A
				N/A	Any Obstructions?	N/A	N/A	Storm Grate/Utility Hazard?	N/A
		Total Cost: \$	1850.00		Obstruction Type			Storm Grate/Utility Type	
						N/A			N/A
