Access Compliance Report

Public Rights-of-Way

(Curb Ramps)

| Intersection ID: N/A | Main Street: BRONSON_DR | Cross Street: TINDALL_PARK_DR | Location: S |

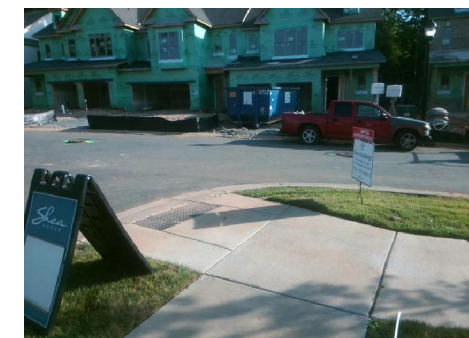
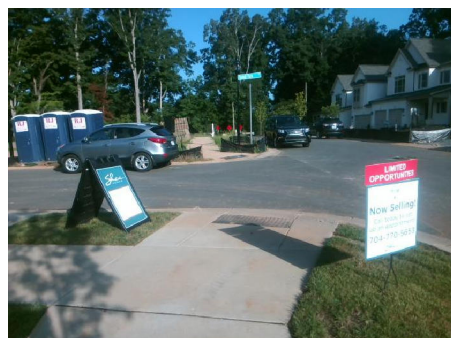
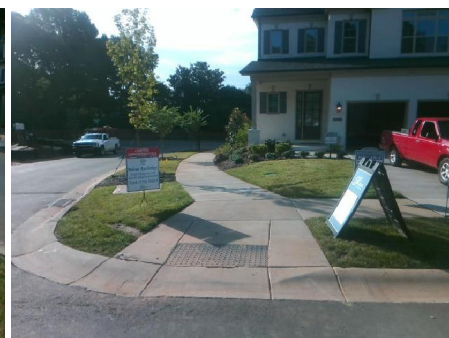
| Compliance | Description | Data | Compliance | Description | Data |
|---|---|---|---|---|---|
| N/A | Ramp Length (in) | 62.0 | Yes | Ramp Slope (%) | 7.1 |
| No | Ramp Width (in) | 47.0 | No | Ramp XSlope (%) | 3.1 |

Remove & Replace Curb Ramp With Two New Directional Ramps or Equivalent.
