Access Compliance Report

Public Rights-of-Way

(Curb Ramps)

Intersection ID: 28395	Main Street: BRIDGEHAMPTON CLUB DR	Cross Street: CHATSWORTH CT	Location: NW
ADA ID: 207F31BE0B7B	Ramp Type: Perp	Initial Pass/Fail: Fail	Overall Compliance: No
Severity Score: 13.75			
Codes/Mitigation Info/Possible Solution		Field Measurements/Component Compliance

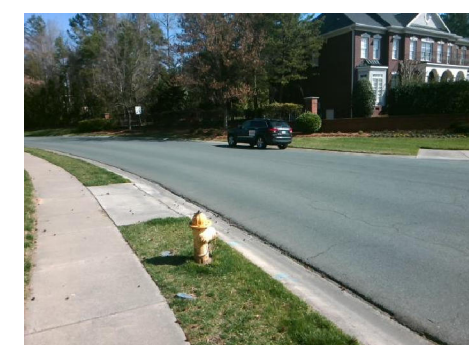
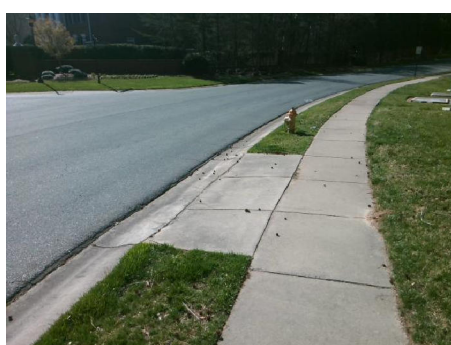
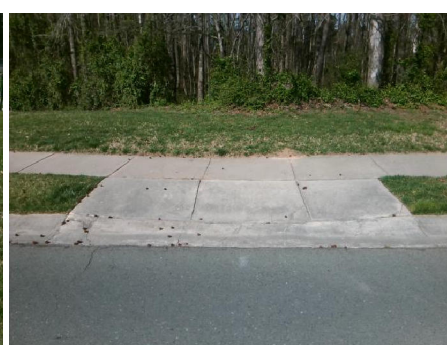
Not Found, R304.2.2, R304.5.3

Compliance	Description	Data	Compliance	Description	Data
N/A	Ramp Length (in)	49.5	No	Ramp Slope (%)	11.9
Yes	Ramp Width (in)	60.0	No	Ramp XSlope (%)	2.3
N/A	Flare Type LT	N/A	N/A	Flare Type RT	N/A
N/A	Flare Slope LT (%)	N/A	N/A	Flare Slope RT (%)	N/A
N/A	Flare Traversable LT?	N/A	N/A	Flare Traversable RT?	N/A
N/A	Landing Length (in)	N/A	N/A	DWS Provided?	N/A
N/A	Landing Width (in)	N/A	N/A	DWS Contrast?	N/A
N/A	Landing Slope (%)	N/A	N/A	DWS Length (in)	N/A
N/A	Landing X Slope (%)	N/A	N/A	DWS Full Width?	N/A
N/A	Landing Curb? (Y/N)	N/A	N/A	DWS Offset (in)	N/A
N/A	Shared Landing?	N/A			
N/A	Gutter Ponding?	N/A	N/A	Gutter Slope (%)	N/A
N/A	Gutter Lip Ht (in)	N/A	N/A	Gutter X Slope (%)	N/A
N/A	Painted X Walk1?	No	N/A	Painted X Walk2?	N/A
	X Walk 1 Direction	To E		X Walk 2 Direction	N/A
N/A	X Walk 1 Width (in)	N/A	N/A	X Walk 2 Width (in)	N/A
	X Walk 1 Slope (%)	5.1		X Walk 2 Slope (%)	N/A
	X Walk 1 X Slope (%)	2.2		X Walk 2 X Slope (%)	N/A

N/A	Ramp inside XWalk1?	N/A	N/A	Ramp inside XWalk2?	N/A
	Road Slope (%)	N/A	N/A	Clear Space?	N/A
	Road X Slope (%)	N/A	N/A	Clear Space to XWalk (in)	N/A
N/A	Any Obstructions?	N/A	N/A	Storm Grate/Utility Hazard?	N/A
	Obstruction Type			Storm Grate/Utility Type	
		N/A			N/A
			Yes	Surface Condition? (G/P)	Good

Remove & Replace Entire Ramp.

Total Cost: \$ 1850.00
