# Access Compliance Report

## Public Rights-of-Way

### (Curb Ramps)

Intersection ID: 9487	Main Street: ARDEN_ST	Cross Street: KOHLER_AV	Location: NW
ADA ID: 209021370448	Ramp Type: Para	Initial Pass/Fail: Fail	Overall Compliance: No
Severity Score: 13.75			
Codes/Mitigation Info/Possible Solution		Field Measurements/Component Compliance

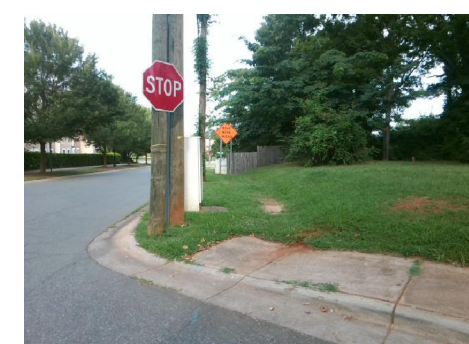
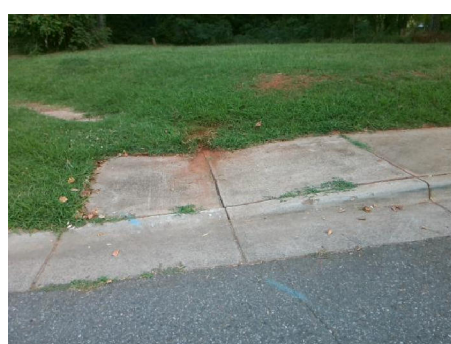
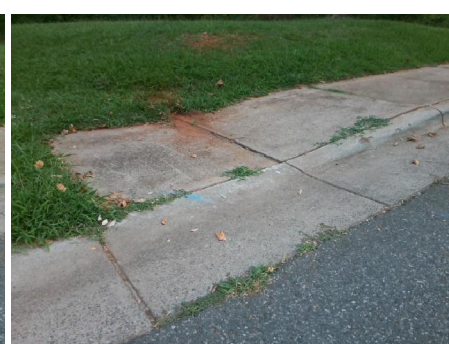
**CURB GAP 1.0**

Compliance	Description	Data	Compliance	Description	Data
N/A	Ramp Length LT (in)	N/A	N/A	Ramp Length RT (in)	67.0
N/A	Ramp Width LT (in)	N/A	Yes	Ramp Width RT (in)	59.0
N/A	Ramp Slope LT (%)	N/A	No	Ramp Slope RT (%)	10.7
N/A	Ramp XSlope LT (%)	N/A	No	Ramp XSlope RT (%)	3.4
N/A	Landing Length (in)	N/A	N/A	DWS Provided?	N/A
N/A	Landing Width (in)	N/A	N/A	DWS Contrast?	N/A
N/A	Landing Slope (%)	N/A	N/A	DWS Length (in)	N/A
N/A	Landing X Slope (%)	N/A	N/A	DWS Full Width?	N/A
N/A	Landing Curb? (Y/N)	N/A	N/A	DWS Offset (in)	N/A
N/A	Shared Landing?	N/A			
N/A	Gutter Ponding?	N/A	N/A	Gutter Slope (%)	N/A
N/A	Gutter Lip Ht (in)	N/A	N/A	Gutter X Slope (%)	N/A
N/A	Painted X Walk1?	No	N/A	Painted X Walk2?	N/A
	X Walk 1 Direction	To S		X Walk 2 Direction	N/A
N/A	X Walk 1 Width (in)	N/A	N/A	X Walk 2 Width (in)	N/A
	X Walk 1 Slope (%)	1.5		X Walk 2 Slope (%)	N/A
	X Walk 1 X Slope (%)	2.6		X Walk 2 X Slope (%)	N/A
N/A	Ramp inside XWalk1?	N/A	N/A	Ramp inside XWalk2?	N/A

Road Slope (%)	N/A	N/A	Clear Space?	N/A
	Road X Slope (%)	N/A	N/A	Clear Space to XWalk (in)	N/A
N/A	Any Obstructions?	N/A	N/A	Storm Grate/Utility Hazard?	N/A
	Obstruction Type			Storm Grate/Utility Type	
		N/A			N/A
			Yes	Surface Condition? (G/P)	Good
			N/A	Curb Slope (%)	15.3

**Remove & Replace Entire Ramp.**
