# Access Compliance Report

## Public Rights-of-Way

### (Curb Ramps)

Intersection ID: 45886	Main Street: BEN_LIVINGSTON_RD	Cross Street: OAK_ST	Location:	N
ADA ID: 209309107D6D	Ramp Type: Perp	Initial Pass/Fail: Fail	Overall Compliance: No	Severity Score: 8.75
Codes/Mitigation Info/Possible Solution		Field Measurements/Component Compliance

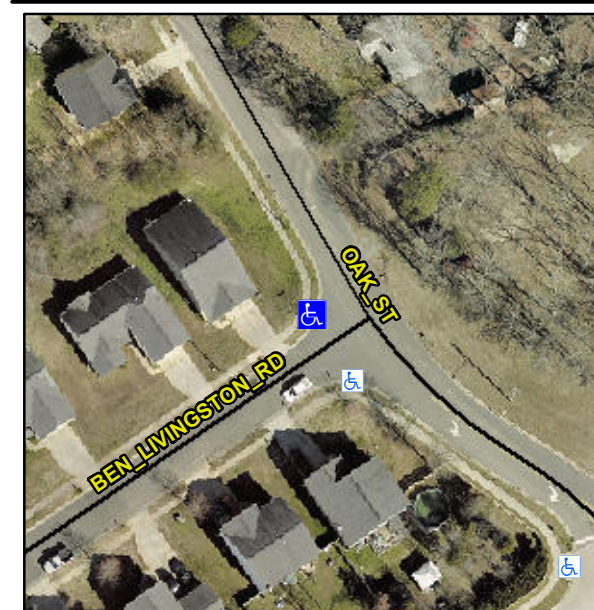
Compliance	Description	Data	Compliance	Description	Data
N/A	Ramp Length (in)	48.0	Yes	Ramp Slope (%)	6.8
No	Ramp Width (in)	47.0	Yes	Ramp XSlope (%)	2.0
N/A	Flare Type LT	N/A	N/A	Flare Type RT	N/A
N/A	Flare Slope LT (%)	N/A	N/A	Flare Slope RT (%)	N/A
N/A	Flare Traversable LT?	N/A	N/A	Flare Traversable RT?	N/A
N/A	Landing Length (in)	N/A	N/A	DWS Provided?	N/A
N/A	Landing Width (in)	N/A	N/A	DWS Contrast?	N/A
N/A	Landing Slope (%)	N/A	N/A	DWS Length (in)	N/A
N/A	Landing X Slope (%)	N/A	N/A	DWS Full Width?	N/A
N/A	Landing Curb? (Y/N)	N/A	N/A	DWS Offset (in)	N/A
N/A	Shared Landing?	N/A			
N/A	Gutter Ponding?	N/A	N/A	Gutter Slope (%)	N/A
N/A	Gutter Lip Ht (in)	0.5	N/A	Gutter X Slope (%)	N/A
N/A	Painted X Walk1?	No	N/A	Painted X Walk2?	N/A
	X Walk 1 Direction	To S		X Walk 2 Direction	N/A
N/A	X Walk 1 Width (in)	N/A	N/A	X Walk 2 Width (in)	N/A
	X Walk 1 Slope (%)	0.6		X Walk 2 Slope (%)	N/A
	X Walk 1 X Slope (%)	2.0		X Walk 2 X Slope (%)	N/A

N/A	Ramp inside XWalk1?	N/A	N/A	Ramp inside XWalk2?	N/A
	Road Slope (%)	N/A	N/A	Clear Space?	N/A
	Road X Slope (%)	N/A	N/A	Clear Space to XWalk (in)	N/A
N/A	Any Obstructions?	N/A	N/A	Storm Grate/Utility Hazard?	N/A
	Obstruction Type			Storm Grate/Utility Type	
		N/A			N/A
			Yes	Surface Condition? (G/P)	Good

**Remove & Replace Entire Ramp.**

**Not Found, R304.5.1**

Total Cost: \$ 1850.00
