Access Compliance Report

Public Rights-of-Way

(Curb Ramps)

Intersection ID: 25823	Main Street: BANNINGTON_RD	Cross Street: PINEVILLE-MATTHEWS_RD	Location: NW
ADA ID: 20A436846F9E	Ramp Type: PerpDiag	Initial Pass/Fail: Fail	Overall Compliance: No
		Severity Score: 12.5

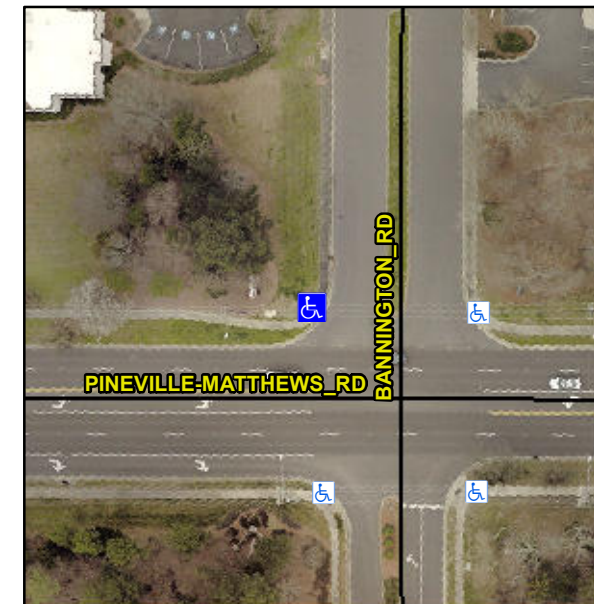
Compliance	Description	Data	Compliance	Description	Data
N/A	Ramp Length (in)	58.0	Yes	Ramp Slope (%)	5.5
Yes	Ramp Width (in)	48.0	No	Ramp XSlope (%)	5.6
N/A	Flare Type LT	N/A	N/A	Flare Type RT	N/A
N/A	Flare Slope LT (%)	N/A	N/A	Flare Slope RT (%)	N/A
N/A	Flare Traversable LT?	N/A	N/A	Flare Traversable RT?	N/A
N/A	Landing Length (in)	N/A	N/A	DWS Provided?	N/A
N/A	Landing Width (in)	N/A	N/A	DWS Contrast?	N/A
N/A	Landing Slope (%)	N/A	N/A	DWS Length (in)	N/A
N/A	Landing X Slope (%)	N/A	N/A	DWS Full Width?	N/A
N/A	Landing Curb? (Y/N)	N/A	N/A	DWS Offset (in)	N/A
N/A	Shared Landing?	N/A			
N/A	Gutter Ponding?	N/A	N/A	Gutter Slope (%)	N/A
N/A	Gutter Lip Ht (in)	N/A	N/A	Gutter X Slope (%)	N/A
N/A	Painted X Walk1?	No	N/A	Painted X Walk2?	No
	X Walk 1 Direction	To S		X Walk 2 Direction	To E
N/A	X Walk 1 Width (in)	N/A	N/A	X Walk 2 Width (in)	N/A
	X Walk 1 Slope (%)	5.6		X Walk 2 Slope (%)	3.1
	X Walk 1 X Slope (%)	1.8		X Walk 2 X Slope (%)	4.6

N/A	Ramp inside XWalk1?	N/A	N/A	Ramp inside XWalk2?	N/A
	Road Slope (%)	5.8	N/A	Clear Space?	N/A
	Road X Slope (%)	1.1	N/A	Clear Space to XWalk (in)	N/A
N/A	Any Obstructions?	N/A	N/A	Storm Grate/Utility Hazard?	N/A
	Obstruction Type			Storm Grate/Utility Type	
		N/A			N/A
		Yes		Surface Condition? (G/P)	Good

Remove & Replace Curb Ramp With Two New Directional Ramps or Equivalent.
