Access Compliance Report

Public Rights-of-Way

(Curb Ramps)

Intersection ID: 14286	Main Street: S_TORRENCE_ST	Cross Street: MAIN_ST	Location:	N
ADA ID: 20ACE342ACFF	Ramp Type: PerpDiag	Initial Pass/Fail: Fail	Overall Compliance: No	Severity Score: 10

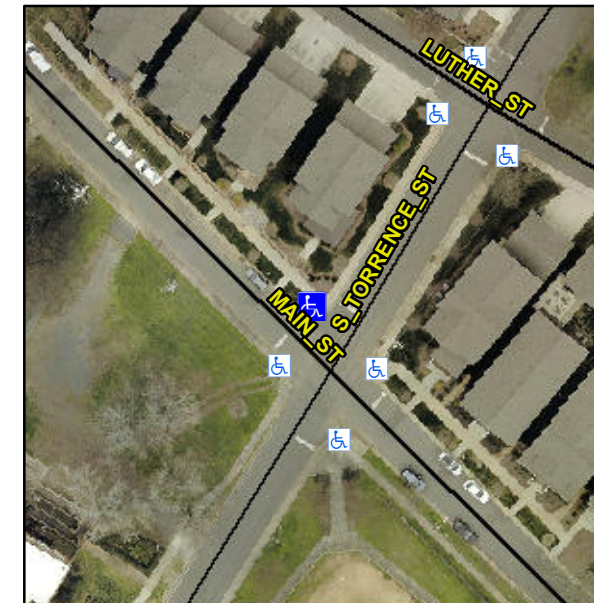
Not Found, R304.5.1, R304.5.3

Compliance	Description	Data	Compliance	Description	Data
N/A	Ramp Length (in)	65.0	Yes	Ramp Slope (%)	7.4
No	Ramp Width (in)	36.0	No	Ramp XSlope (%)	4.5
N/A	Flare Type LT	N/A	N/A	Flare Type RT	N/A
N/A	Flare Slope LT (%)	N/A	N/A	Flare Slope RT (%)	N/A
N/A	Flare Traversable LT?	N/A	N/A	Flare Traversable RT?	N/A
N/A	Landing Length (in)	N/A	N/A	DWS Provided?	N/A
N/A	Landing Width (in)	N/A	N/A	DWS Contrast?	N/A
N/A	Landing Slope (%)	N/A	N/A	DWS Length (in)	N/A
N/A	Landing X Slope (%)	N/A	N/A	DWS Full Width?	N/A
N/A	Landing Curb? (Y/N)	N/A	N/A	DWS Offset (in)	N/A
N/A	Shared Landing?	N/A			
N/A	Gutter Ponding?	N/A	N/A	Gutter Slope (%)	N/A
N/A	Gutter Lip Ht (in)	N/A	N/A	Gutter X Slope (%)	N/A
N/A	Painted X Walk1?	No	N/A	Painted X Walk2?	No
	X Walk 1 Direction	To SW		X Walk 2 Direction	To SE
N/A	X Walk 1 Width (in)	N/A	N/A	X Walk 2 Width (in)	N/A
	X Walk 1 Slope (%)	1.3		X Walk 2 Slope (%)	3.1
	X Walk 1 X Slope (%)	1.0		X Walk 2 X Slope (%)	0.8

N/A	Ramp inside XWalk1?	N/A	N/A	Ramp inside XWalk2?	N/A
	Road Slope (%)	2.2	N/A	Clear Space?	N/A
	Road X Slope (%)	2.8	N/A	Clear Space to XWalk (in)	N/A
N/A	Any Obstructions?	N/A	N/A	Storm Grate/Utility Hazard?	N/A
	Obstruction Type			Storm Grate/Utility Type	
		N/A			N/A
			Yes	Surface Condition? (G/P)	Good

Remove & Replace Curb Ramp With Two New Directional Ramps or Equivalent.
