Intersection ID: 13966	Main Street: FAULCONBRIDGE_RD	Cross Street: HOLLIROSE_DR	Location:	NW
ADA ID: 20B7E25FA913	Ramp Type: BlendTrans1	Initial Pass/Fail: Fail	Overall Compliance: No	Severity Score: 8.75

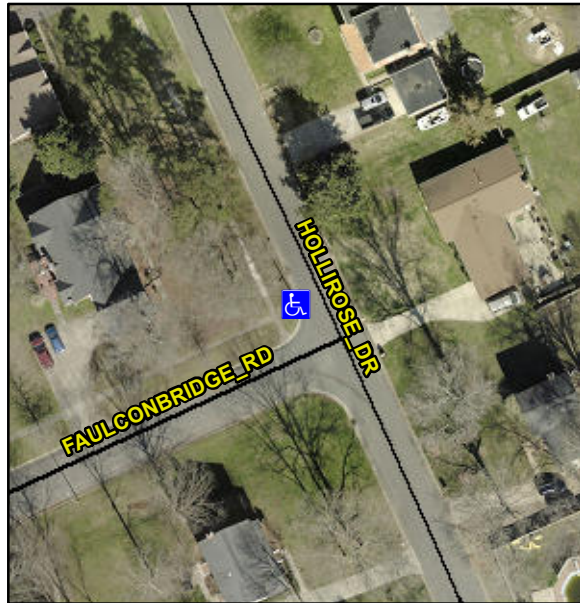
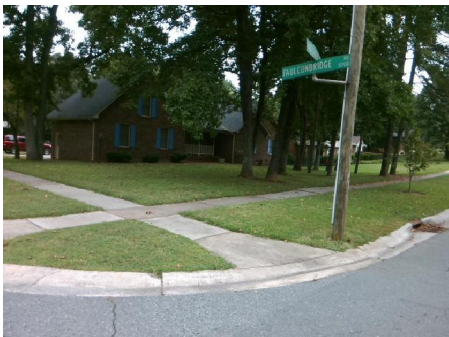
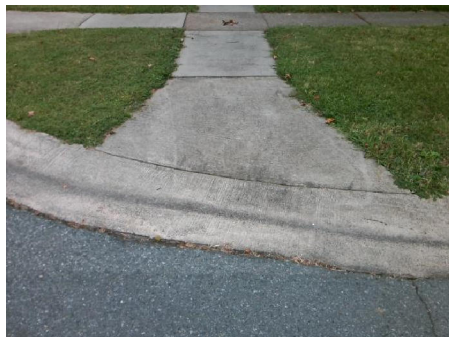
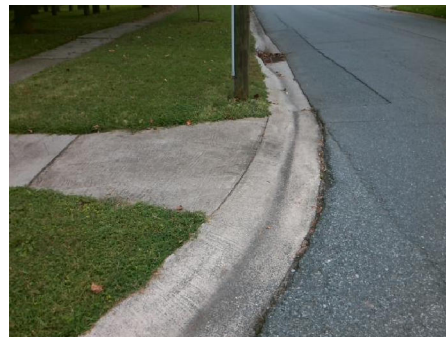
Not Found, R304.5.1

Compliance	Description	Data	Compliance	Description	Data
N/A	Ramp Length (in)	59.0	Yes	BlendTrans Slope (%)	3.0
No	Ramp Width (in)	47.0	Yes	BlendTrans XSlope (%)	0.2
N/A	Flare Type LT	N/A	N/A	Flare Type RT	N/A
N/A	Flare Slope LT (%)	N/A	N/A	Flare Slope RT (%)	N/A
N/A	Flare Traversable LT?	N/A	N/A	Flare Traversable RT?	N/A
N/A	Landing Length (in)	N/A	N/A	DWS Provided?	N/A
N/A	Landing Width (in)	N/A	N/A	DWS Contrast?	N/A
N/A	Landing Slope (%)	N/A	N/A	DWS Length (in)	N/A
N/A	Landing X Slope (%)	N/A	N/A	DWS Full Width?	N/A
N/A	Landing Curb? (Y/N)	N/A	N/A	DWS Offset (in)	N/A
N/A	Shared Landing?	N/A			
N/A	Gutter Ponding?	N/A	N/A	Gutter Slope (%)	N/A
N/A	Gutter Lip Ht (in)	N/A	N/A	Gutter X Slope (%)	N/A
N/A	Painted X Walk1?	No	N/A	Painted X Walk2?	N/A
	X Walk 1 Direction	To E		X Walk 2 Direction	N/A
	X Walk 1 Width (in)	N/A		X Walk 2 Width (in)	N/A
	X Walk 1 Slope (%)	4.9		X Walk 2 Slope (%)	N/A
	X Walk 1 X Slope (%)	0.8		X Walk 2 X Slope (%)	N/A

N/A	Ramp inside XWalk1?	N/A	N/A	Ramp inside XWalk2?	N/A
	Road Slope (%)	0.8		Clear Space?	N/A
	Road X Slope (%)	4.9	N/A	Clear Space to XWalk (in)	N/A
N/A	Any Obstructions?	N/A	N/A	Storm Grate/Utility Hazard?	N/A
	Obstruction Type			Storm Grate/Utility Type	
		N/A			N/A
			Yes	Surface Condition? (G/P)	Good
			No	Curb Slope (%)	14.0

Remove & Replace Curb Ramp With Two New Directional Ramps or Equivalent.
