## Access Compliance Report Public Rights-of-Way (Curb Ramps)

Intersection ID: 5317	Main Street: OLD_STATESVILLE_RD			Street:	OAK_DR	Location:	E		
ADA ID: 20BE656EA73A	Ramp Type: Perp			Initial Pass/Fail: Fail Overall Compliance:			nce: N	o Severity Score:	33.75
Codes/Mitigation Info/Possible Solution				Field Measurements/Component Compliance					
A lake	180	Possible Solutions:		Compliance Description		Data Compliance Description		Data	
	R	Remove & Replace Entire Ram	<b>o</b> .	N/A	Ramp Length (in)	59.0	No	Ramp Slope (%)	12.4

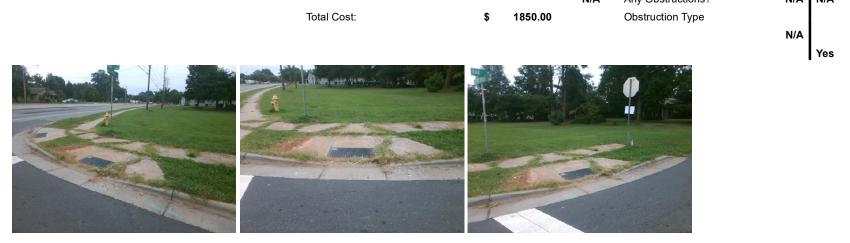
C. Conten			No	Ramp Width (in)	38.0	Yes	Ramp XSlope (%)	1.5
				N/A	Flare Type LT	N/A	N/A	Flare Type RT	N/A
	R. Wald			N/A	Flare Slope LT (%)	N/A	N/A	Flare Slope RT (%)	N/A
<u>A</u>	No. 19 Mar			N/A	Flare Traversable LT?	N/A	N/A	Flare Traversable RT?	N/A
				N/A	Landing Length (in)	N/A	N/A	DWS Provided?	N/A
		Surveyor Notes:		N/A	Landing Width (in)	N/A	N/A	DWS Contrast?	N/A
	free .	N/A		N/A	Landing Slope (%)	N/A	N/A	DWS Length (in)	N/A
