Access Compliance Report

Public Rights-of-Way

(Curb Ramps)

Intersection ID: 45182	Main Street: MAPLEHURST_DR	Cross Street: SOCIETY_ST	Location: SW
ADA ID: 20D534E7C470	Ramp Type: BlendTrans2	Initial Pass/Fail: Fail	Overall Compliance: No
Severity Score: 8.75			
Codes/Mitigation Info/Possible Solution		Field Measurements/Component Compliance

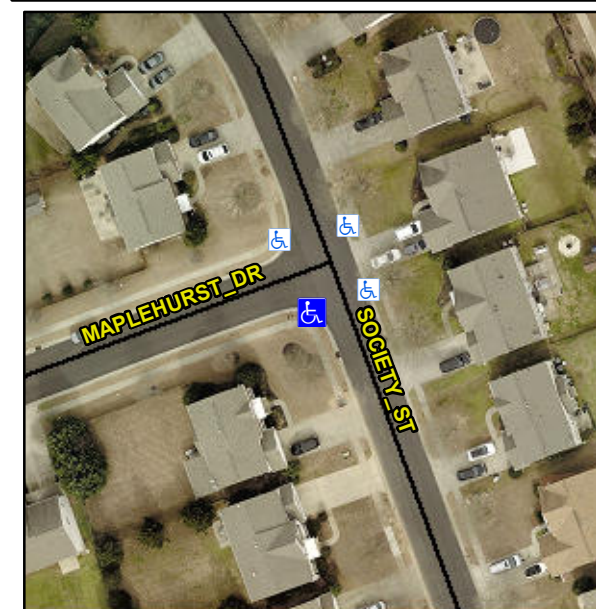
Not Found, R304.5.1

Compliance	Description	Data	Compliance	Description	Data
N/A	Ramp Length (in)	94.0	Yes	BlendTrans Slope (%)	1.2
No	Ramp Width (in)	46.0	Yes	BlendTrans XSlope (%)	1.0
N/A	Flare Type LT	N/A	N/A	Flare Type RT	N/A
N/A	Flare Slope LT (%)	N/A	N/A	Flare Slope RT (%)	N/A
N/A	Flare Traversable LT?	N/A	N/A	Flare Traversable RT?	N/A
N/A	Landing Length (in)	N/A	N/A	DWS Provided?	N/A
N/A	Landing Width (in)	N/A	N/A	DWS Contrast?	N/A
N/A	Landing Slope (%)	N/A	N/A	DWS Length (in)	N/A
N/A	Landing X Slope (%)	N/A	N/A	DWS Full Width?	N/A
N/A	Landing Curb? (Y/N)	N/A	N/A	DWS Offset (in)	N/A
N/A	Shared Landing?	N/A			
N/A	Gutter Ponding?	N/A	N/A	Gutter Slope (%)	N/A
N/A	Gutter Lip Ht (in)	N/A	N/A	Gutter X Slope (%)	N/A
N/A	Painted X Walk1?	No	N/A	Painted X Walk2?	No
	X Walk 1 Direction	To NE		X Walk 2 Direction	To NW
	X Walk 1 Width (in)	N/A		X Walk 2 Width (in)	N/A
	X Walk 1 Slope (%)	2.1		X Walk 2 Slope (%)	0.7
	X Walk 1 X Slope (%)	1.1		X Walk 2 X Slope (%)	2.4

N/A	Ramp inside XWalk1?	N/A	N/A	Ramp inside XWalk2?	N/A
	Road Slope (%)	0.1		Clear Space?	N/A
	Road X Slope (%)	2.0	N/A	Clear Space to XWalk (in)	N/A
N/A	Any Obstructions?	N/A	N/A	Storm Grate/Utility Hazard?	N/A
	Obstruction Type			Storm Grate/Utility Type	
		N/A			N/A
			Yes	Surface Condition? (G/P)	Good
			No	Curb Slope (%)	7.9

Remove & Replace Curb Ramp With Two New Directional Ramps or Equivalent.

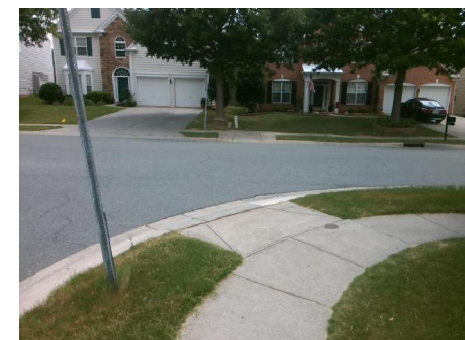
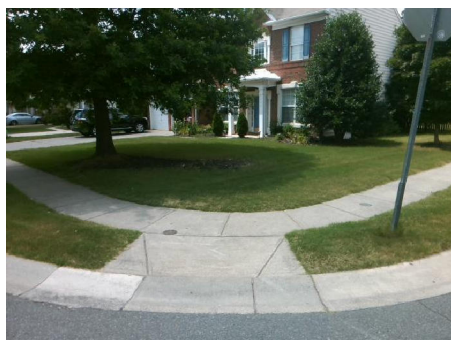
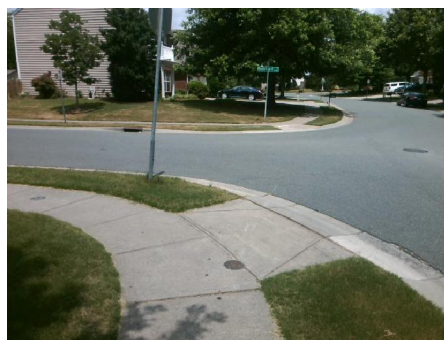
Street 1 Name SOCIETY ST
 Stop Condition-Street 1 None
 Street 2 Name MAPLEHURST DR
 Stop Condition-Street 2 StopSign
