# Access Compliance Report

## Public Rights-of-Way

### (Curb Ramps)

Intersection ID: 22029	Main Street: PIONEER_AV	Cross Street: WESTINGHOUSE_BV	Location: NE
ADA ID: 20ED9ACC972D	Ramp Type: IslandPerp	Initial Pass/Fail: Fail	Overall Compliance: No
		Severity Score: 22.5

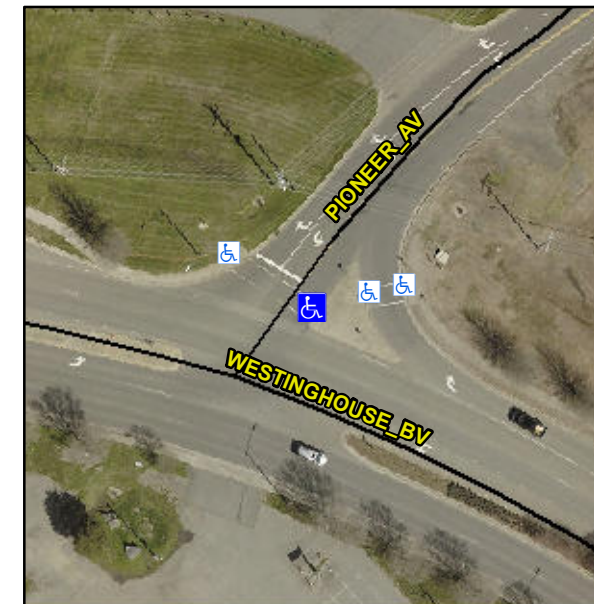
Compliance	Description	Data	Compliance	Description	Data
N/A	Ramp Length (in)	48.0	No	Ramp Slope (%)	11.2
No	Ramp Width (in)	37.0	No	Ramp XSlope (%)	4.3
N/A	Flare Type LT	N/A	N/A	Flare Type RT	N/A
N/A	Flare Slope LT (%)	N/A	N/A	Flare Slope RT (%)	N/A
N/A	Flare Traversable LT?	N/A	N/A	Flare Traversable RT?	N/A
N/A	Landing Length (in)	N/A	N/A	DWS Provided?	N/A
N/A	Landing Width (in)	N/A	N/A	DWS Contrast?	N/A
N/A	Landing Slope (%)	N/A	N/A	DWS Length (in)	N/A
N/A	Landing X Slope (%)	N/A	N/A	DWS Full Width?	N/A
N/A	Landing Curb? (Y/N)	N/A	N/A	DWS Offset (in)	N/A
N/A	Shared Landing?	N/A			
N/A	Gutter Ponding?	N/A	N/A	Gutter Slope (%)	N/A
N/A	Gutter Lip Ht (in)	N/A	N/A	Gutter X Slope (%)	N/A
N/A	Painted X Walk1?	Yes	N/A	Painted X Walk2?	N/A
	X Walk 1 Direction	To NW		X Walk 2 Direction	N/A
N/A	X Walk 1 Width (in)	111.0	N/A	X Walk 2 Width (in)	N/A
	X Walk 1 Slope (%)	2.2		X Walk 2 Slope (%)	N/A
	X Walk 1 X Slope (%)	1.1		X Walk 2 X Slope (%)	N/A

N/A	Ramp inside XWalk1?	Yes	N/A	Ramp inside XWalk2?	N/A
	Road Slope (%)	N/A	N/A	Clear Space?	N/A
	Road X Slope (%)	N/A	N/A	Clear Space to XWalk (in)	N/A
N/A	Any Obstructions?	N/A	N/A	Storm Grate/Utility Hazard?	N/A
	Obstruction Type			Storm Grate/Utility Type	
		N/A			N/A
			Yes	Surface Condition? (G/P)	Good

**Remove & Replace Entire Ramp.**

**R304.5.1, R304.2.2, R304.5.3**

Total Cost: \$ 3400.00
