# Access Compliance Report

## Public Rights-of-Way

### (Curb Ramps)

| Intersection ID: 32099 | Main Street: STEELE_CREEK_RD | Cross Street: ROTHE_HOUSE_RD | Location: SE |

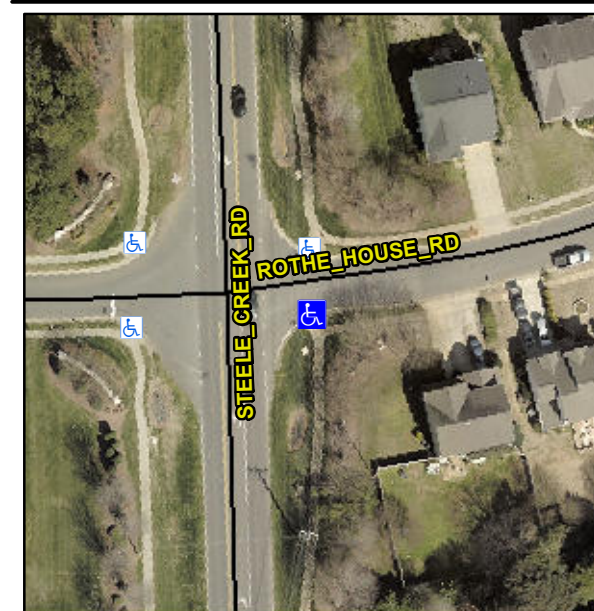
Possible Solutions:

| Compliance | Description | Data | Compliance | Description | Data |
|---|---|---|---|---|---|
| N/A | Ramp Length (in) | 136.0 | Yes | Ramp Slope (%) | 7.6 |
| Yes | Ramp Width (in) | 57.5 | Yes | Ramp XSlope (%) | 0.1 |
| Yes | Landing Length (in) | 52.5 | No | DWS Provided? | No |
| No | Landing Slope (%) | 4.0 | N/A | DWS Length (in) | N/A |

**Remove & Replace Curb Ramp With Two New Directional Ramps or Equivalent.**
