# Access Compliance Report

## Public Rights-of-Way

### (Curb Ramps)

Intersection ID: N/A	Main Street: SOUTHGROVE ST	Cross Street: WAVERLY WALK AV	Location: SE
ADA ID: 210E136B8F53	Ramp Type: Perp	Initial Pass/Fail: Fail	Overall Compliance: No
Codes/Mitigation Info/Possible Solution		Field Measurements/Component Compliance

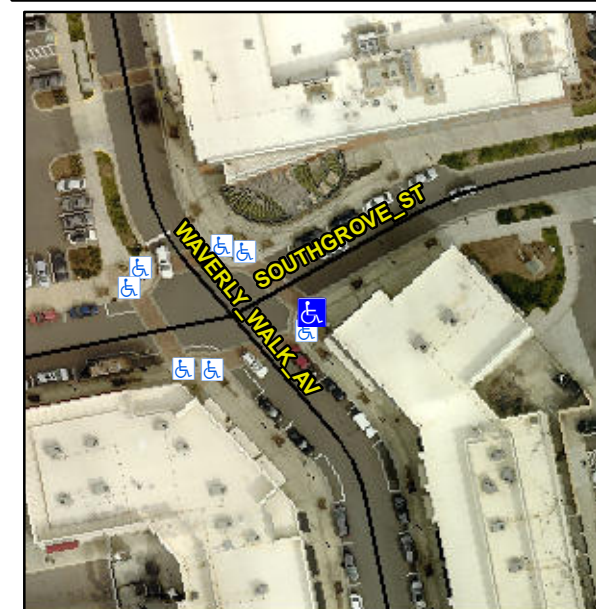
**R304.2.2, R304.5.3**

Compliance	Description	Data	Compliance	Description	Data
N/A	Ramp Length (in)	66.0	No	Ramp Slope (%)	9.2
Yes	Ramp Width (in)	48.0	No	Ramp XSlope (%)	2.6
N/A	Flare Type LT	N/A	N/A	Flare Type RT	N/A
N/A	Flare Slope LT (%)	N/A	N/A	Flare Slope RT (%)	N/A
N/A	Flare Traversable LT?	N/A	N/A	Flare Traversable RT?	N/A
N/A	Landing Length (in)	N/A	N/A	DWS Provided?	N/A
N/A	Landing Width (in)	N/A	N/A	DWS Contrast?	N/A
N/A	Landing Slope (%)	N/A	N/A	DWS Length (in)	N/A
N/A	Landing X Slope (%)	N/A	N/A	DWS Full Width?	N/A
N/A	Landing Curb? (Y/N)	N/A	N/A	DWS Offset (in)	N/A
N/A	Shared Landing?	N/A			
N/A	Gutter Ponding?	N/A	N/A	Gutter Slope (%)	N/A
N/A	Gutter Lip Ht (in)	1.0	N/A	Gutter X Slope (%)	N/A
N/A	Painted X Walk1?	Yes	N/A	Painted X Walk2?	N/A
	X Walk 1 Direction	To NW		X Walk 2 Direction	N/A
N/A	X Walk 1 Width (in)	103.5	N/A	X Walk 2 Width (in)	N/A
	X Walk 1 Slope (%)	0.4		X Walk 2 Slope (%)	N/A
	X Walk 1 X Slope (%)	2.2		X Walk 2 X Slope (%)	N/A

N/A	Ramp inside XWalk1?	Yes	N/A	Ramp inside XWalk2?	N/A
	Road Slope (%)	N/A	N/A	Clear Space?	N/A
	Road X Slope (%)	N/A	N/A	Clear Space to XWalk (in)	N/A
N/A	Any Obstructions?	N/A	N/A	Storm Grate/Utility Hazard?	N/A
	Obstruction Type			Storm Grate/Utility Type	
		N/A			N/A
			Yes	Surface Condition? (G/P)	Good

Possible Solutions:

**Remove & Replace Entire Ramp.**
