Access Compliance Report

Public Rights-of-Way

(Curb Ramps)

Intersection ID: 27595	Main Street: BALLANTYNE COMMONS PY	Cross Street: BALLANTYNE MEADOWS DR	Location: N
ADA ID: 214776AD39BD	Ramp Type: Perp	Initial Pass/Fail: Fail	Overall Compliance: No
Severity Score: 21.25			
Codes/Mitigation Info/Possible Solution		Field Measurements/Component Compliance

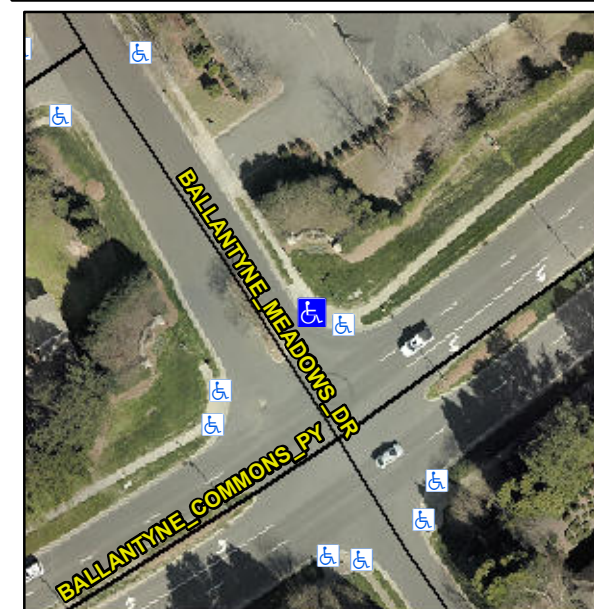
Not Found, R304.5.1, R304.5.3

Compliance	Description	Data	Compliance	Description	Data
N/A	Ramp Length (in)	107.0	Yes	Ramp Slope (%)	6.0
No	Ramp Width (in)	44.0	No	Ramp XSlope (%)	5.6
N/A	Flare Type LT	N/A	N/A	Flare Type RT	N/A
N/A	Flare Slope LT (%)	N/A	N/A	Flare Slope RT (%)	N/A
N/A	Flare Traversable LT?	N/A	N/A	Flare Traversable RT?	N/A
N/A	Landing Length (in)	N/A	N/A	DWS Provided?	N/A
N/A	Landing Width (in)	N/A	N/A	DWS Contrast?	N/A
N/A	Landing Slope (%)	N/A	N/A	DWS Length (in)	N/A
N/A	Landing X Slope (%)	N/A	N/A	DWS Full Width?	N/A
N/A	Landing Curb? (Y/N)	N/A	N/A	DWS Offset (in)	N/A
N/A	Shared Landing?	N/A			
N/A	Gutter Ponding?	N/A	N/A	Gutter Slope (%)	N/A
N/A	Gutter Lip Ht (in)	N/A	N/A	Gutter X Slope (%)	N/A
N/A	Painted X Walk1?	No	N/A	Painted X Walk2?	N/A
	X Walk 1 Direction	To SW		X Walk 2 Direction	N/A
N/A	X Walk 1 Width (in)	N/A	N/A	X Walk 2 Width (in)	N/A
	X Walk 1 Slope (%)	2.2		X Walk 2 Slope (%)	N/A
	X Walk 1 X Slope (%)	2.0		X Walk 2 X Slope (%)	N/A

N/A	Ramp inside XWalk1?	N/A	N/A	Ramp inside XWalk2?	N/A
	Road Slope (%)	N/A	N/A	Clear Space?	N/A
	Road X Slope (%)	N/A	N/A	Clear Space to XWalk (in)	N/A
N/A	Any Obstructions?	N/A	N/A	Storm Grate/Utility Hazard?	N/A
	Obstruction Type			Storm Grate/Utility Type	
		N/A			N/A
		Yes		Surface Condition? (G/P)	Good

Possible Solutions:

Remove & Replace Entire Ramp.
