# Access Compliance Report

## Public Rights-of-Way

### (Curb Ramps)

Intersection ID: 44012	Main Street: BRADWELL_DR	Cross Street: LANGHAM_CT	Location: SE
ADA ID: 21490FEC0B65	Ramp Type: PerpDiag	Initial Pass/Fail: Fail	Overall Compliance: No
Severity Score: 33.75			
Codes/Mitigation Info/Possible Solution		Field Measurements/Component Compliance

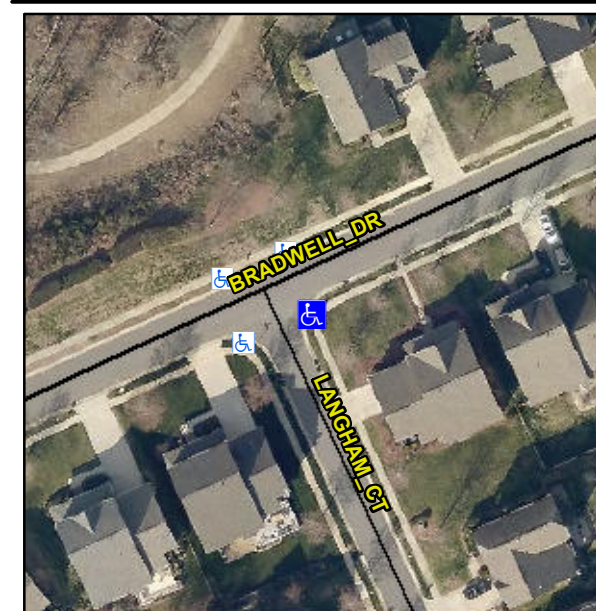
**Not Found, R304.5.1, R304.2.2**

Compliance	Description	Data	Compliance	Description	Data
N/A	Ramp Length (in)	49.5	No	Ramp Slope (%)	13.0
No	Ramp Width (in)	36.0	Yes	Ramp XSlope (%)	1.3
N/A	Flare Type LT	N/A	N/A	Flare Type RT	N/A
N/A	Flare Slope LT (%)	N/A	N/A	Flare Slope RT (%)	N/A
N/A	Flare Traversable LT?	N/A	N/A	Flare Traversable RT?	N/A
N/A	Landing Length (in)	N/A	N/A	DWS Provided?	N/A
N/A	Landing Width (in)	N/A	N/A	DWS Contrast?	N/A
N/A	Landing Slope (%)	N/A	N/A	DWS Length (in)	N/A
N/A	Landing X Slope (%)	N/A	N/A	DWS Full Width?	N/A
N/A	Landing Curb? (Y/N)	N/A	N/A	DWS Offset (in)	N/A
N/A	Shared Landing?	N/A			
N/A	Gutter Ponding?	N/A	N/A	Gutter Slope (%)	N/A
N/A	Gutter Lip Ht (in)	N/A	N/A	Gutter X Slope (%)	N/A
N/A	Painted X Walk1?	No	N/A	Painted X Walk2?	No
	X Walk 1 Direction	To N		X Walk 2 Direction	To W
N/A	X Walk 1 Width (in)	N/A	N/A	X Walk 2 Width (in)	N/A
	X Walk 1 Slope (%)	3.6		X Walk 2 Slope (%)	1.4
	X Walk 1 X Slope (%)	2.6		X Walk 2 X Slope (%)	2.3

N/A	Ramp inside XWalk1?	N/A	N/A	Ramp inside XWalk2?	N/A
	Road Slope (%)	1.0	N/A	Clear Space?	N/A
	Road X Slope (%)	2.2	N/A	Clear Space to XWalk (in)	N/A
N/A	Any Obstructions?	N/A	N/A	Storm Grate/Utility Hazard?	N/A
	Obstruction Type			Storm Grate/Utility Type	
		N/A			N/A
		Yes		Surface Condition? (G/P)	Good

**Remove & Replace Curb Ramp With Two New Directional Ramps or Equivalent.**

Total Cost: \$ 3200.00
