Access Compliance Report

Public Rights-of-Way

(Curb Ramps)

| Intersection ID: 14726 | Main Street: REMOUNT_RD | Cross Street: S_TRYON_ST | Location: | N |

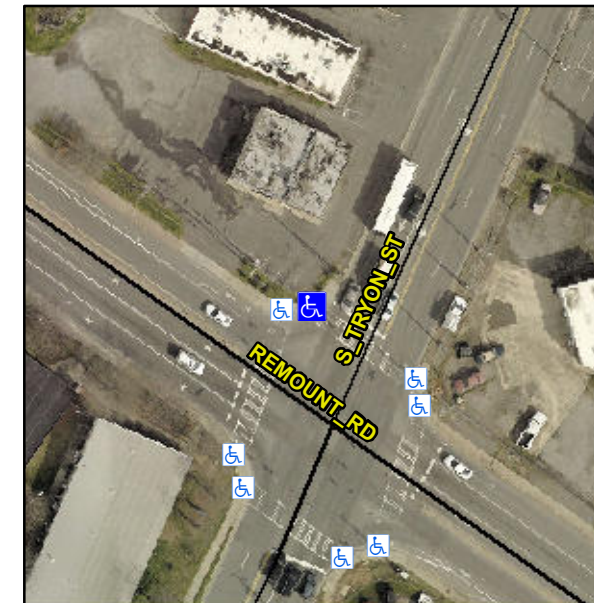
| ADA ID: 2163A2FA72A8 | Ramp Type: Perp | Initial Pass/Fail: Fail | Overall Compliance: No | Severity Score: 22.5 |

Not Found, R304.5.1, R304.2.2, R304.5.3

| Compliance | Description | Data | Compliance | Description | Data |
|---|---|---|---|---|---|
| N/A | Ramp Length (in) | 72.0 | No | Ramp Slope (%) | 10.6 |
| No | Ramp Width (in) | 47.0 | No | Ramp XSlope (%) | 3.1 |

Remove & Replace Entire Ramp.

Total Cost: \$ 1850.00
