## Access Compliance Report Public Rights-of-Way (Curb Ramps)

Intersection ID: 43093 Main Street: N\_POPLAR\_ST Cross Street: W\_10TH\_ST Location: W

ADA ID: 21653E7F02EA Ramp Type: BlendTrans1 Initial Pass/Fail: Fail Overall Compliance: No Severity Score: 8.75

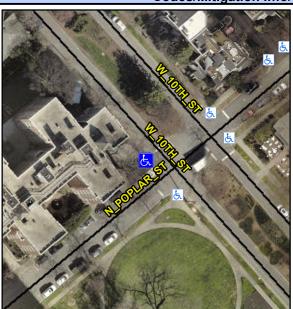
Not Found, R304.5.1

Compliance Description		Data	Compliance Description		Data
N/A	Ramp Length (in)	57.0	Yes	BlendTrans Slope (%)	3.5
No	Ramp Width (in)	46.0	Yes	BlendTrans XSlope (%)	1.1
N/A	Flare Type LT	N/A	N/A	Flare Type RT	N/A
N/A	Flare Slope LT (%)	N/A	N/A	Flare Slope RT (%)	N/A
N/A	Flare Traversable LT?	N/A	N/A	Flare Traversable RT?	N/A
N/A	Landing Length (in)	N/A	N/A	DWS Provided?	N/A
N/A	Landing Width (in)	N/A	N/A	DWS Contrast?	N/A
N/A	Landing Slope (%)	N/A	N/A	DWS Length (in)	N/A
N/A	Landing X Slope (%)	N/A	N/A	DWS Full Width?	N/A
N/A	Landing Curb? (Y/N)	N/A	N/A	DWS Offset (in)	N/A
N/A	Shared Landing?	N/A			
N/A	Gutter Ponding?	N/A	N/A	Gutter Slope (%)	N/A
N/A	Gutter Lip Ht (in)	N/A	N/A	Gutter X Slope (%)	N/A
N/A	Painted X Walk1?	No	N/A	Painted X Walk2?	No
	X Walk 1 Direction	To SE		X Walk 2 Direction	To NE
	X Walk 1 Width (in)	N/A		X Walk 2 Width (in)	N/A
	X Walk 1 Slope (%)	5.4		X Walk 2 Slope (%)	3.9
	X Walk 1 X Slope (%)	0.6		X Walk 2 X Slope (%)	3.6

N/A	Ramp inside XWalk1?	N/A	N/A	Ramp inside XWalk2?	N/A
	Road Slope (%)	0.6		Clear Space?	N/A
	Road X Slope (%)	6.2	N/A	Clear Space to XWalk (in)	N/A
N/A	Any Obstructions?	N/A	N/A	Storm Grate/Utility Hazard?	N/A

Remove & Replace Curb Ramp With Two New Directional Ramps or Equivalent.

Total Cost: \$ 3200.00
